Introduction to PD

October 2014

Presented by:
Dr Lee Renforth,
Managing Director
HVPD Ltd

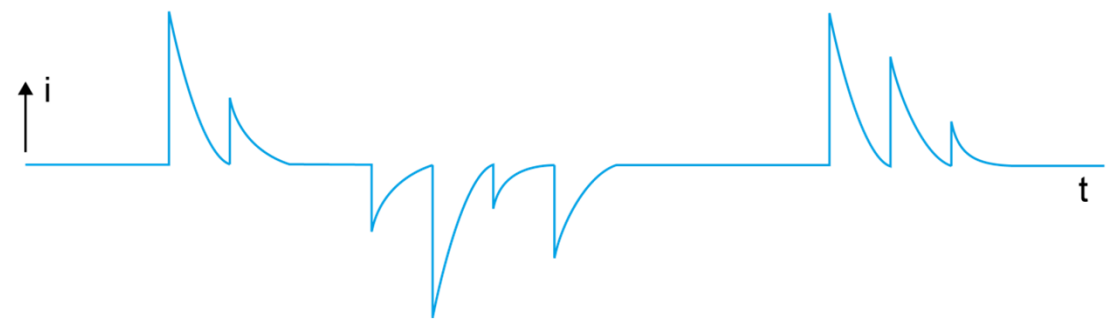
Actual current pulses
(stochastically occurring)

$V^+, V^- =$ PD inception voltages

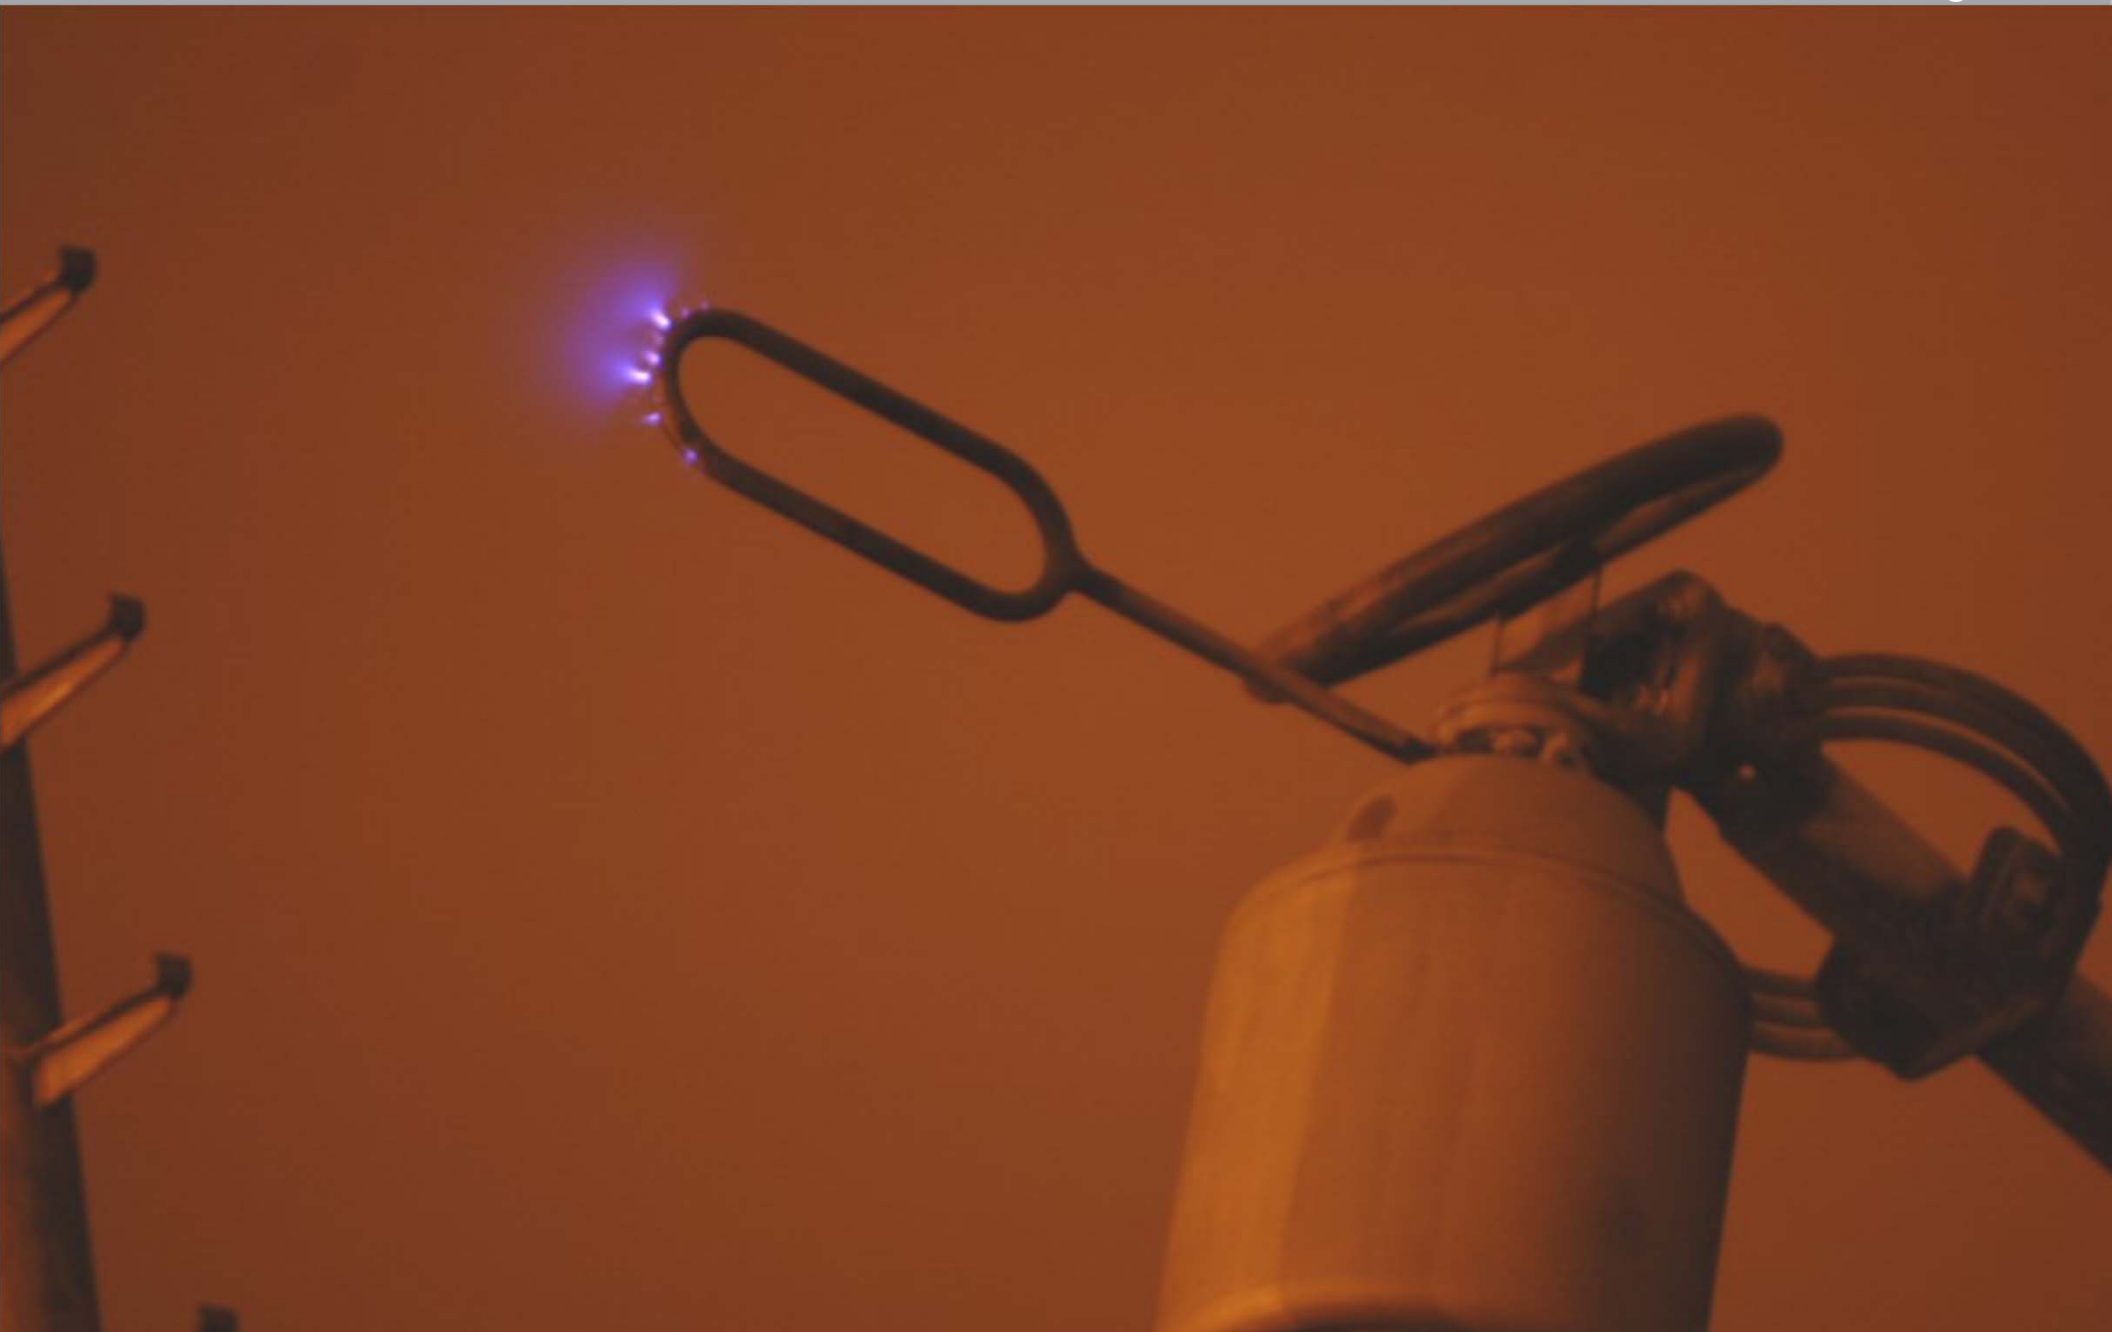
- Incepted from sharp points on HV conductors
- Also possible from sharp points on ground

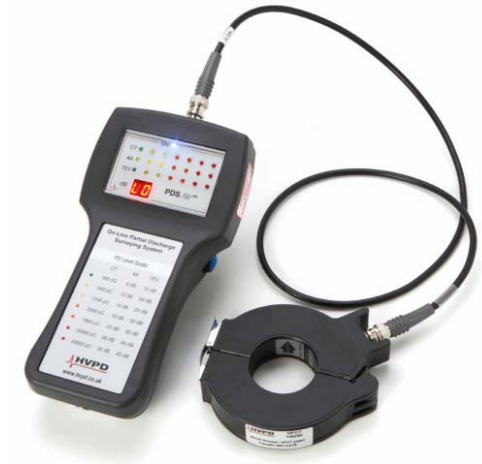
**HVPD PDSAir™
Handheld PD Surveying Tool**

Phase 1 – Detection

- Simple equipment
- Initial indication of PD level/severity

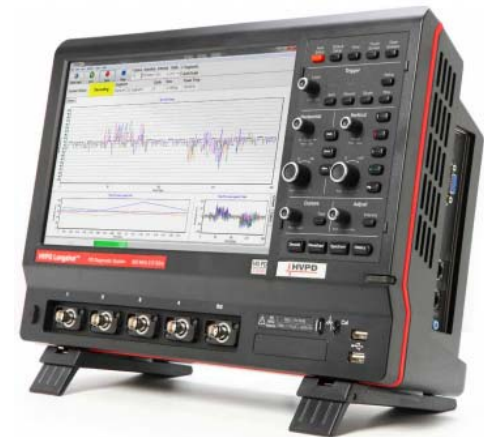
**HVPD Longshot™
Diagnostic OLPD Test Unit**

Phase 2 – Diagnostics/Location

- More advanced hardware/noise rejection
- PD diagnosis and location within the cable/plant
- Digital PD detector with PC for analysis and reporting

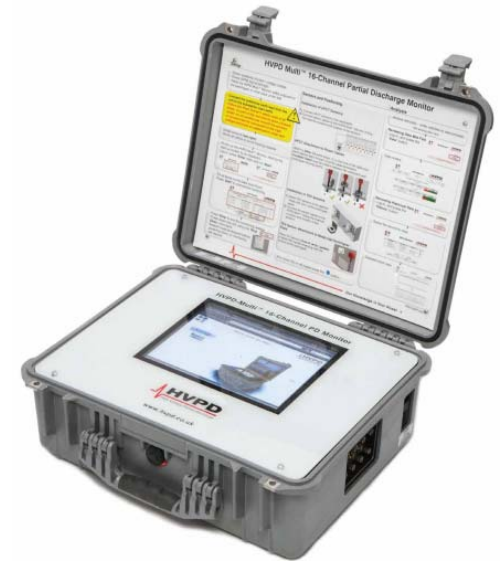
**HVPD Multi™
Portable Monitor**

Phase 3 & 4 – Temporary/Permanent Monitoring

- Temporary or permanent hardware
- Trends PD over time and captures any trend to failure
- Web-based UI/SCADA alarms
- Simple and advanced options:
 - Simple hardware without diagnostic capabilities, generates alarm signals only
 - Advanced hardware with diagnostic capabilities

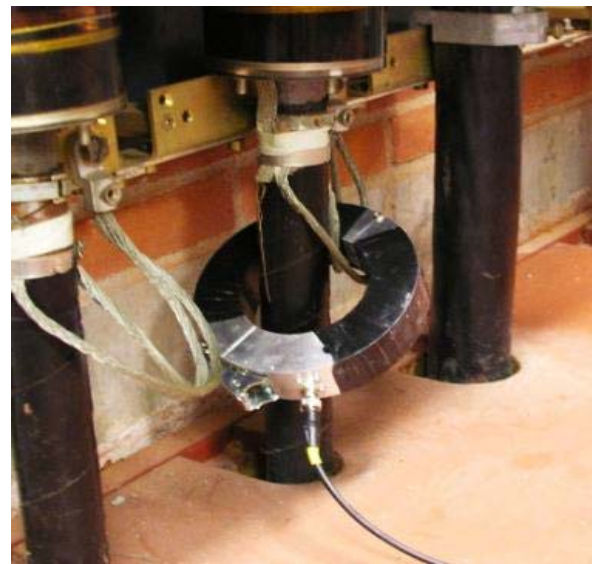
Three Core Belted Cable with HFCT on Common Screen

Available Waveform Display

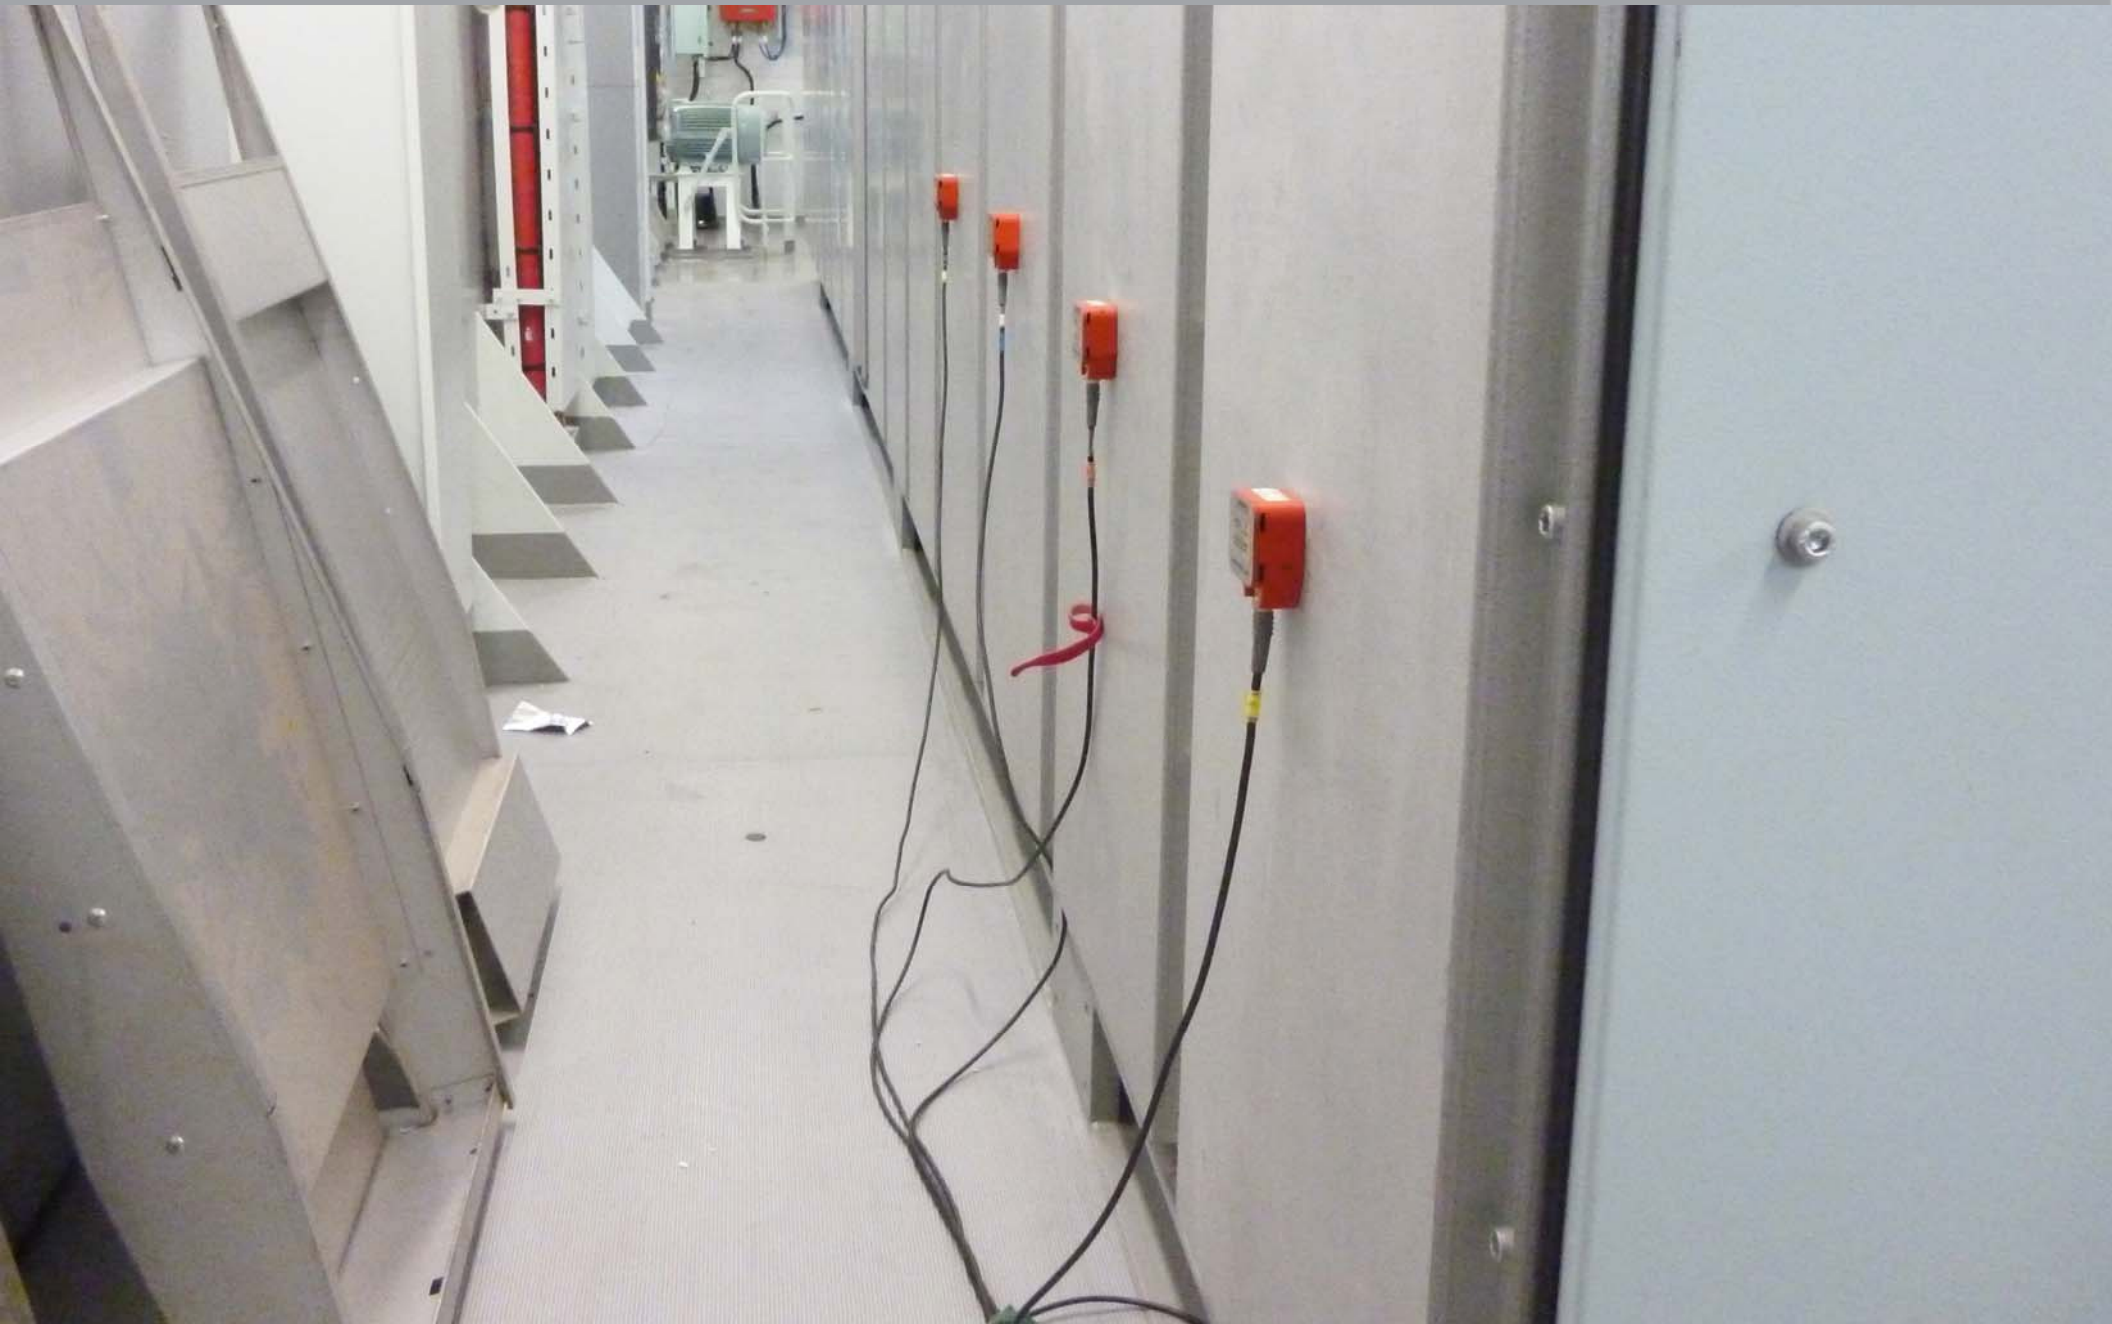
- PD site within switchgear: Phase–Earth discharge
- EM signals radiate from PD site and couple onto metal-clad housing
- Signals emerge on the outer surface at openings in metal housing

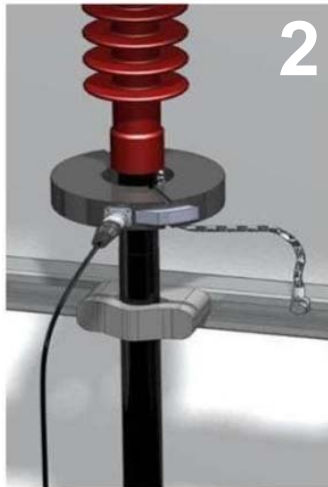
HFCT on cable with Earth brought back through (**i+**)

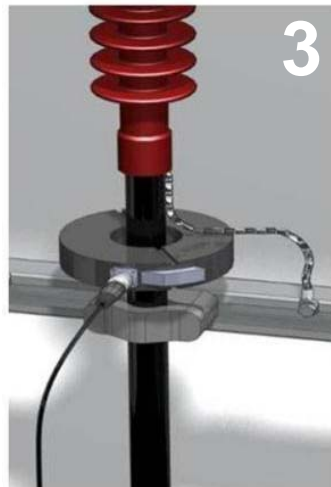
HFCT around cable (**i- + i+ = 0**)

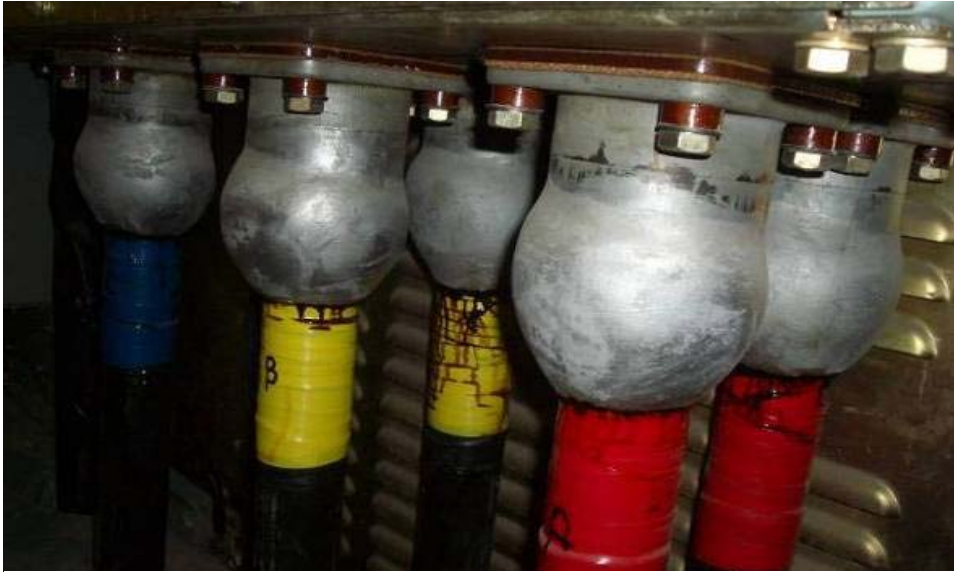
Solidly bonded - lead plumbed

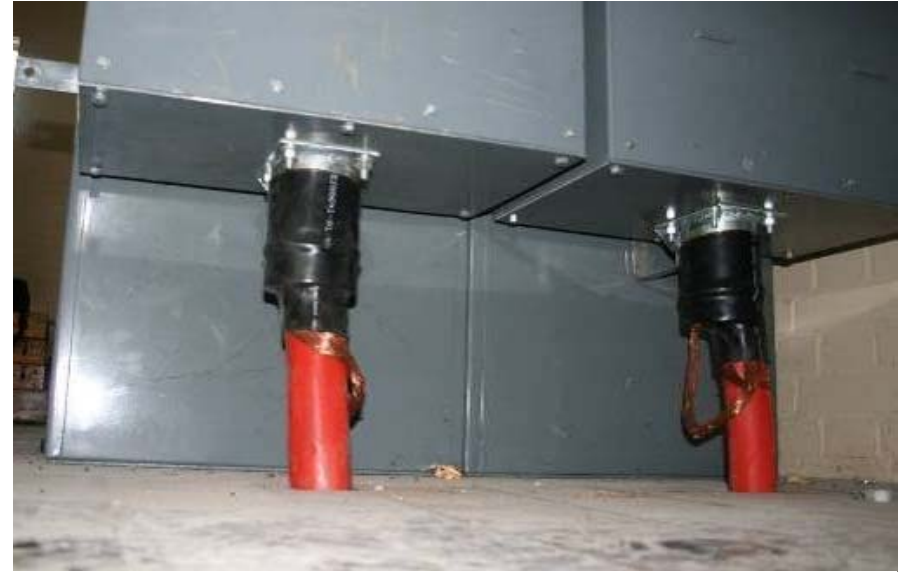
Solidly bonded - No insulated gland

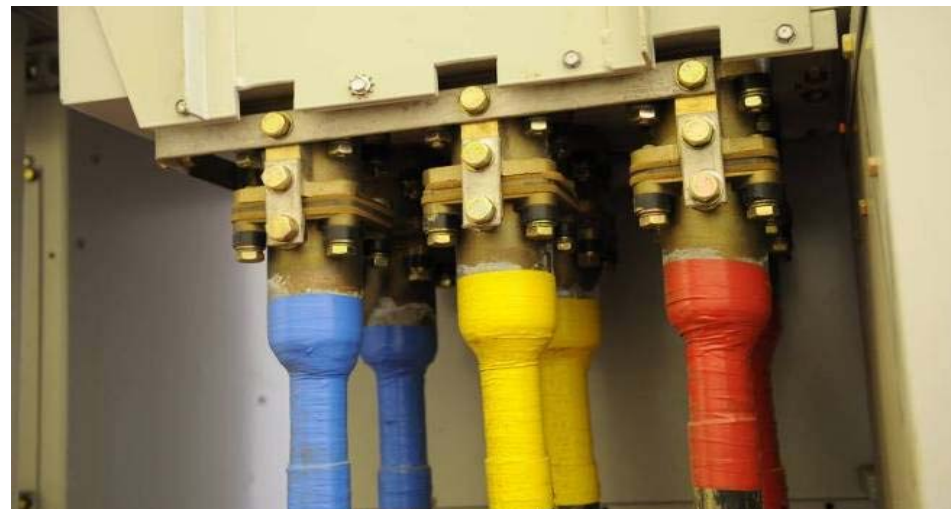
Shorting links

- Short outage to attach
- Permanent installation with external connection point
- Periodic testing/monitoring without subsequent outages

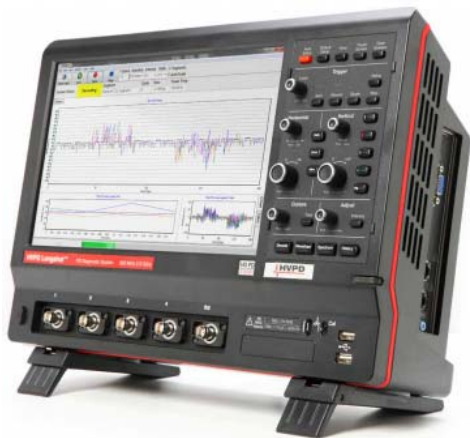
**Matched Length
Co-axial Signal
Cables**

Measured Signals on 4x TEVs

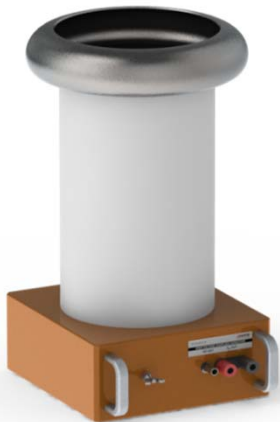
Off-line unit

- Conventional sensor for factory/lab tests
- Placed in parallel with cable/plant under test
- Requires galvanic connection to the plant under test
- Common application for rotating machines/switchgear

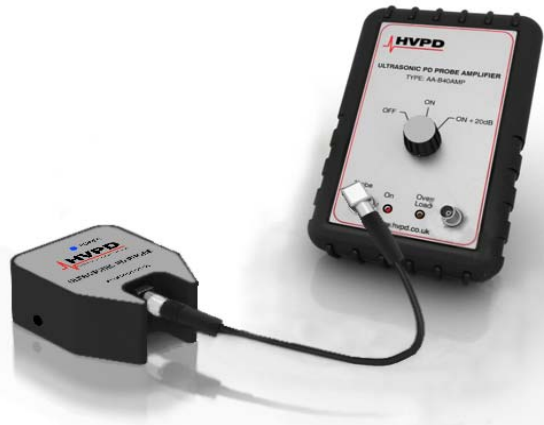
Airborne Acoustic Probe and Amplifier

- Sensitive to local PD sites
- From 10 kHz to 1.2 MHz (≈ 40 kHz common)
 - Airborne – line of sight
 - Corona
 - Surface discharge

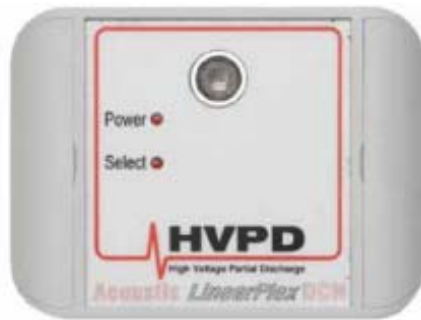
Airborne Acoustic Linearplex Sensor

- Contact
 - Vibration of equipment housing
 - Internal PD
 - Surface discharge

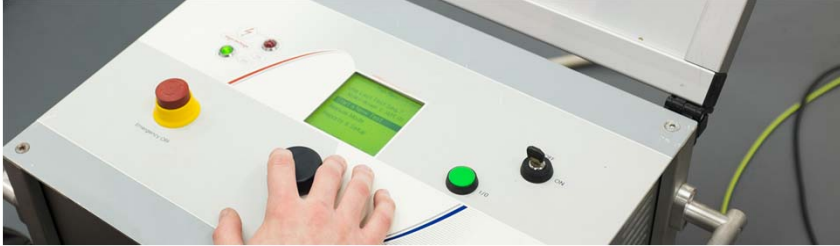
1. VLF (Very Low Frequency) (0.01–0.1 Hz)
example supplier: Baur (Austria), B2HV (Germany)

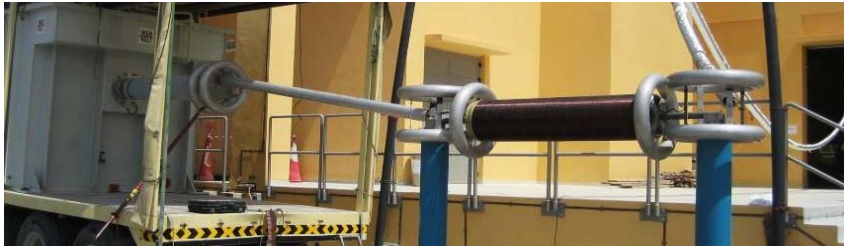
2. Resonant Test Systems (RTS)
example supplier: High-Volt (Germany)

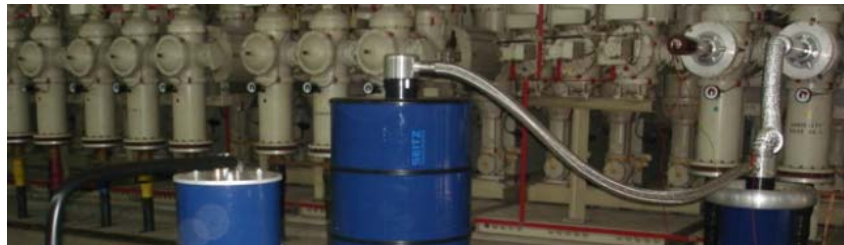
4. Damped AC / Oscillating Wave (OWTS)
example suppliers: Seitz, SEBAkmt (Germany)

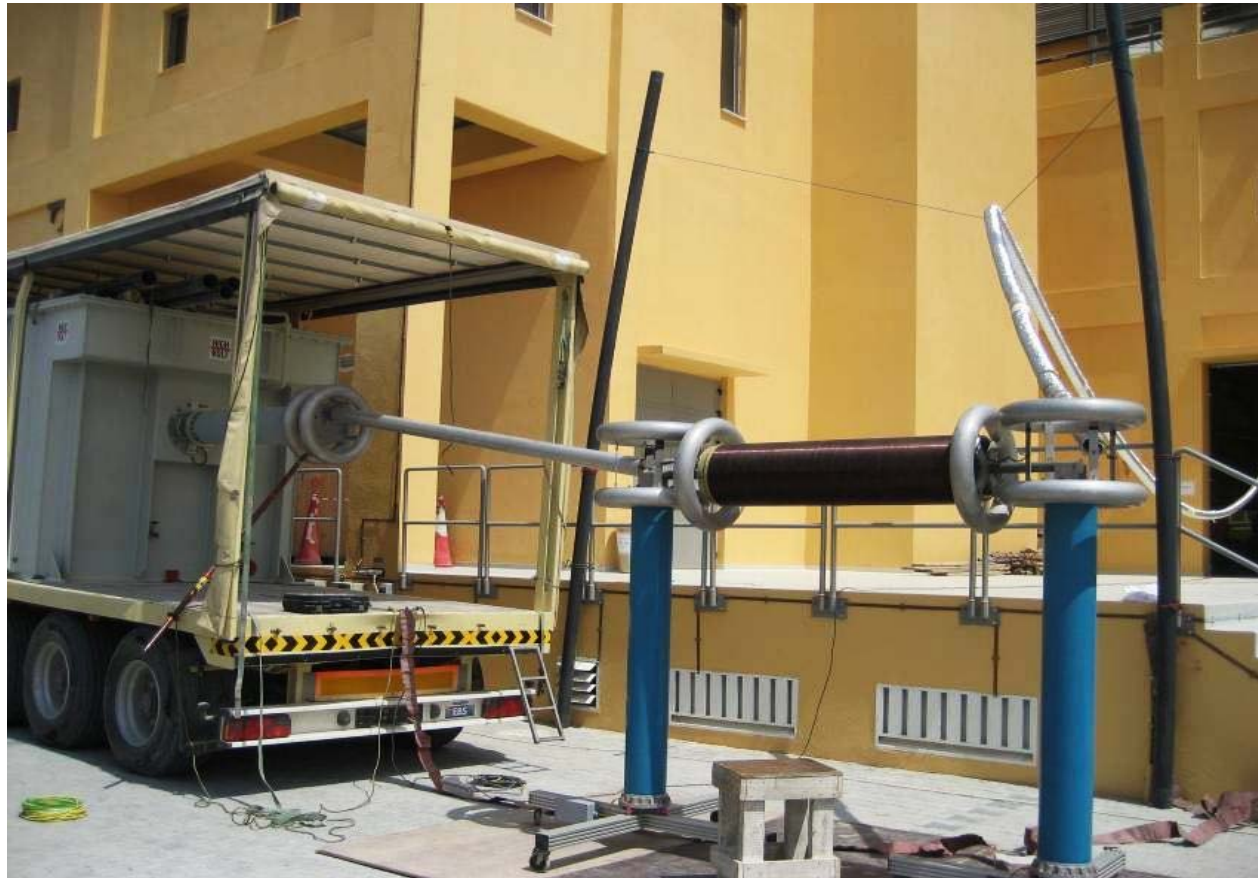
83 A/260 kV (1650 nF) AC Resonant Test System (for 132–220 kV cables)

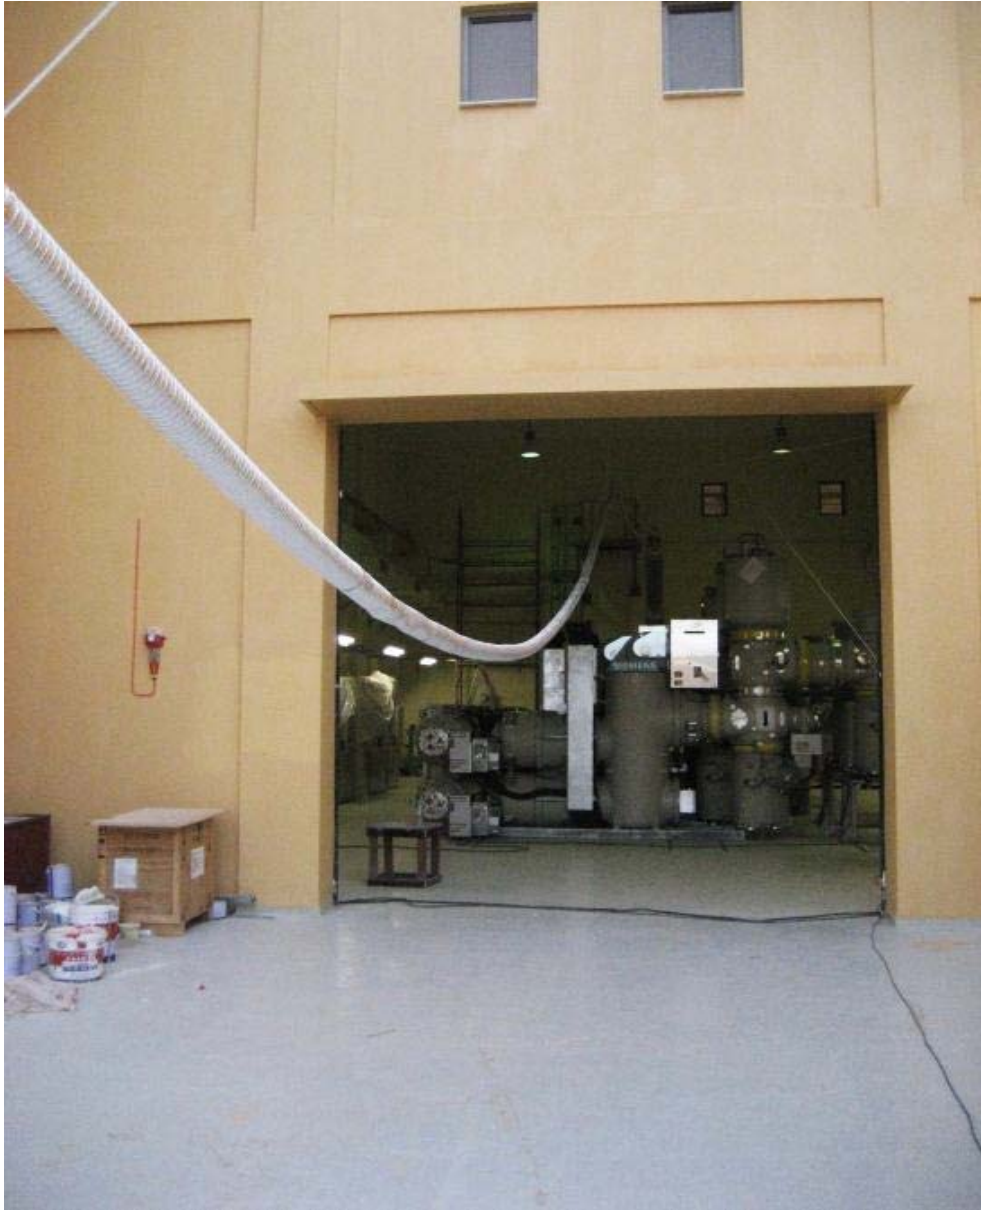
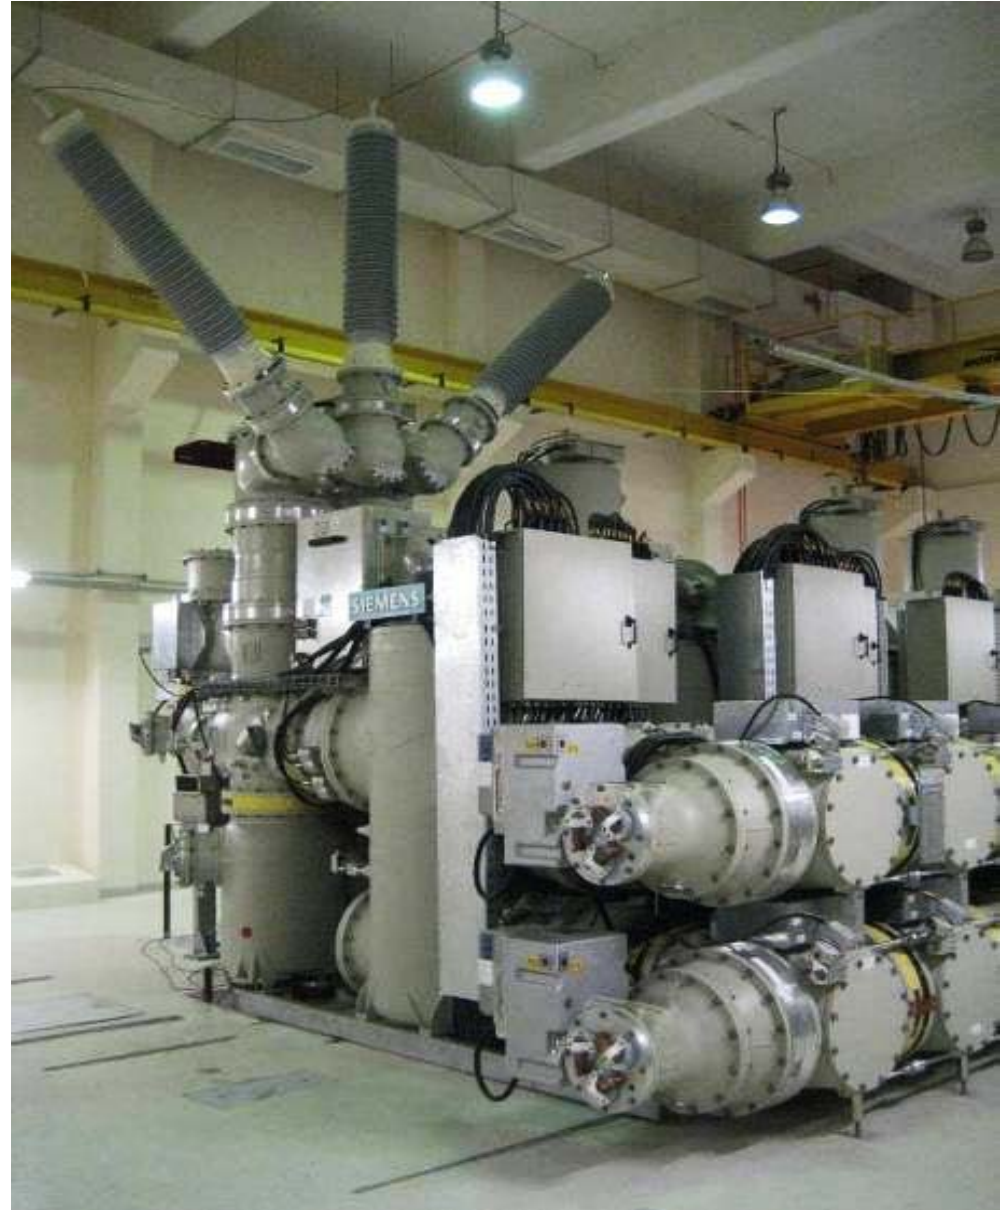
- Noise generated by RTS frequency convertor.
- Blocking impedance helps with filtering.
- Can be gated out with dedicated channel.
- PD event recognition or high pass filters often more effective.

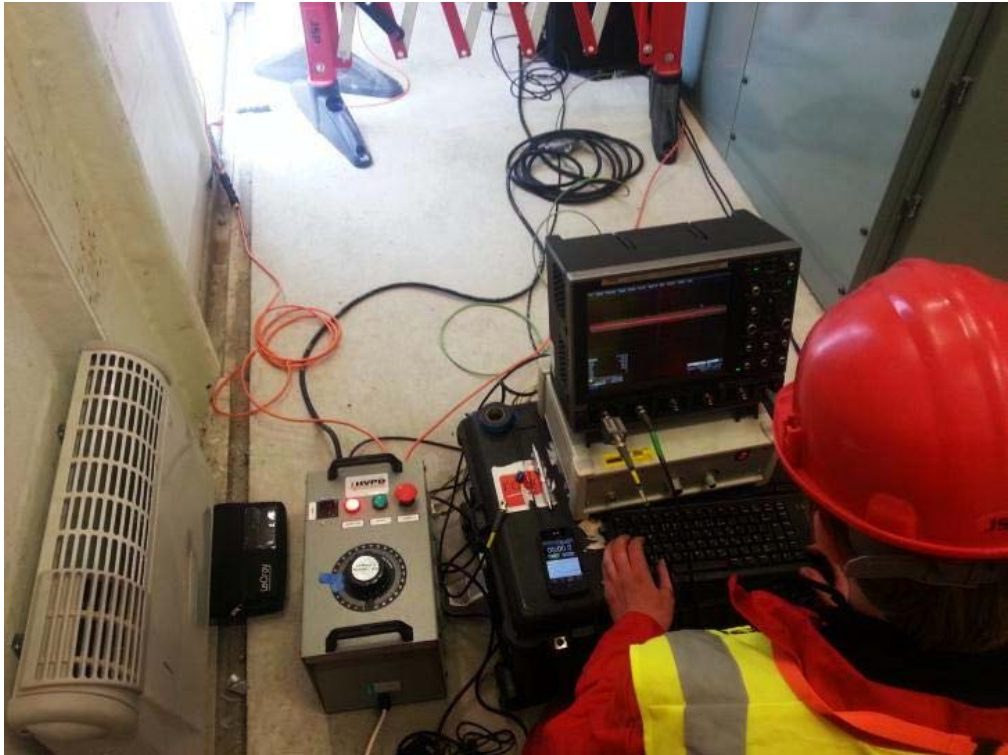
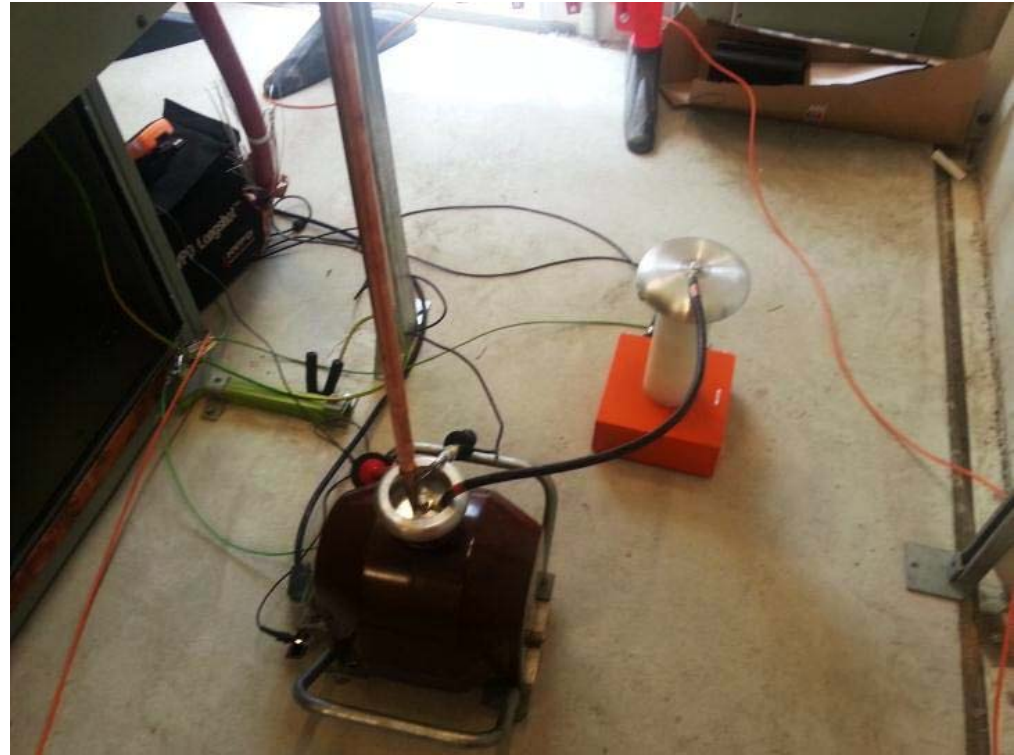
- The off-line test equipment and HVPD Longshot™.
- Voltage was applied (as per IEC 62271-200:2012) to each individual phase in turn with other phases isolated.

- Low levels of PD with peaks up to 54 pC were detected at 1.1 U₀ (13.2 kV phase to ground)
- Concluded the PD was not originating in the breaker sections (Breaker open and closed). PD was isolated within the Bushing and visual inspection was recommended (dirt, moisture or signs or tracking).
- The PD levels detected were considered to be low however maximum permissible partial discharge quantity at 1.1 U₀ shall be ultimately agreed between the manufacturer and the end user as per IEC 62271-200:2012.

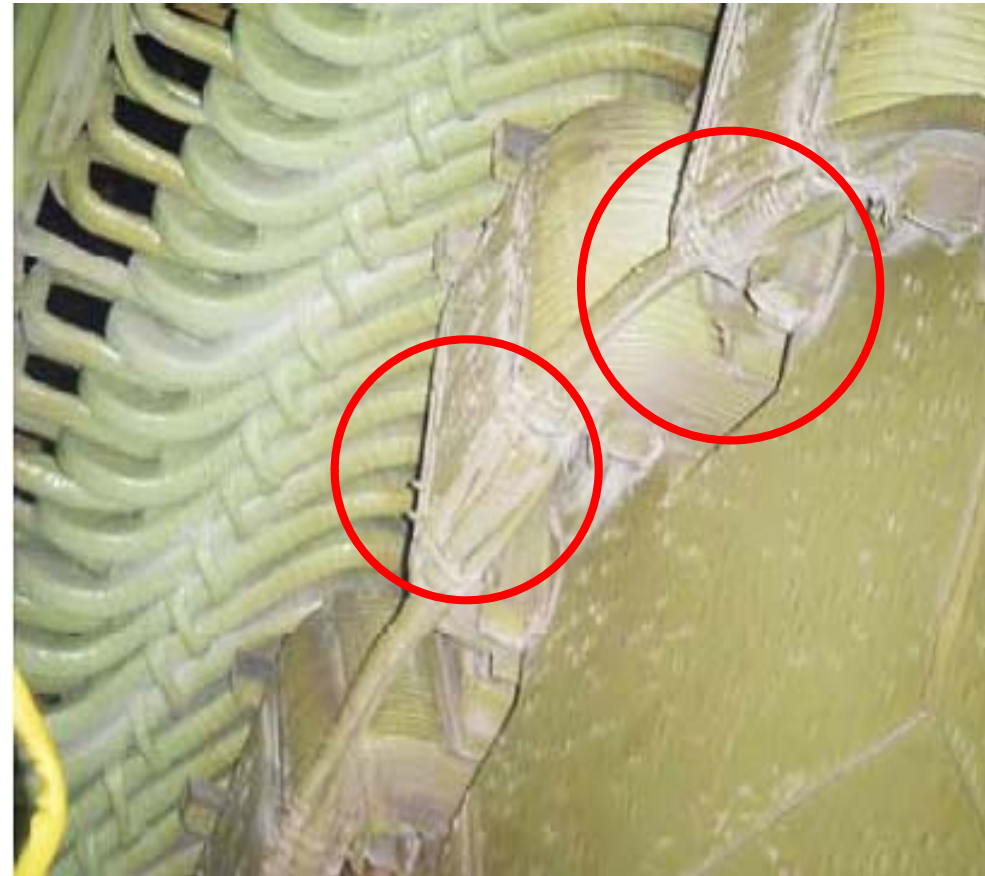
- White oxide deposits at the end windings of the stator: a by-product of surface discharge activity
- The problem caused by a coolant leak.
- Recommendations: clean the end windings, fix the coolant leak and re-seal access hatches.

- Tests performed over 12 months to trend PD data.
- Low-cost, simple maintenance performed on generators in 2008 to remove dust, dirt and oil mist observed.
- PD levels after maintenance reduced from 'Red = Unreliable' to 'Green = OK'.

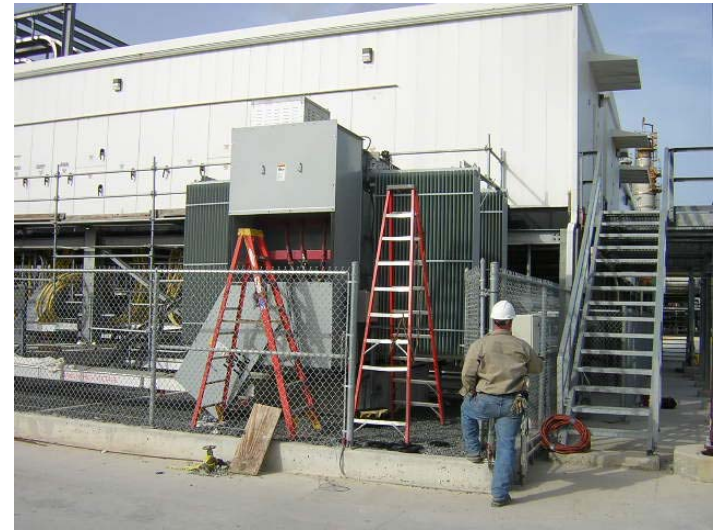
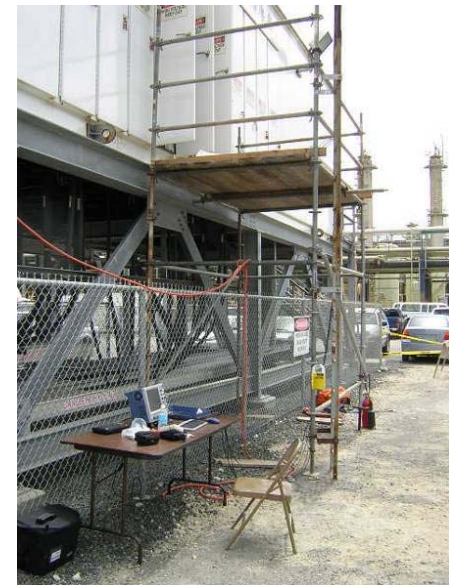
- Following a failure of a 34.5/5 kV 10 MVA transformer, it was decided to carry out OLPD testing on the 'sister' transformer.
- Tests were carried out on-line, measurements made at both transformer and 34.5 kV Substation – takes into account possible radiation of PD signals from other items of plant (i.e. connecting cables & switchgear).

- PD activity was found on the circuit and isolated to the transformer side of the cable.
- Further tests at the transformer revealed the likely source of the PD was in the *Phase B* of the 34.5 kV cable termination, transformer bushing or end winding.
- To isolate the PD source to either the cable or transformer components, the 34.5 kV cables on phases A, B and C were disconnected from the transformer and tested under working voltage supplied from the substation.
- No PD was detected on this test and thus through process of elimination it was concluded that the PD pulses originate from the transformer.

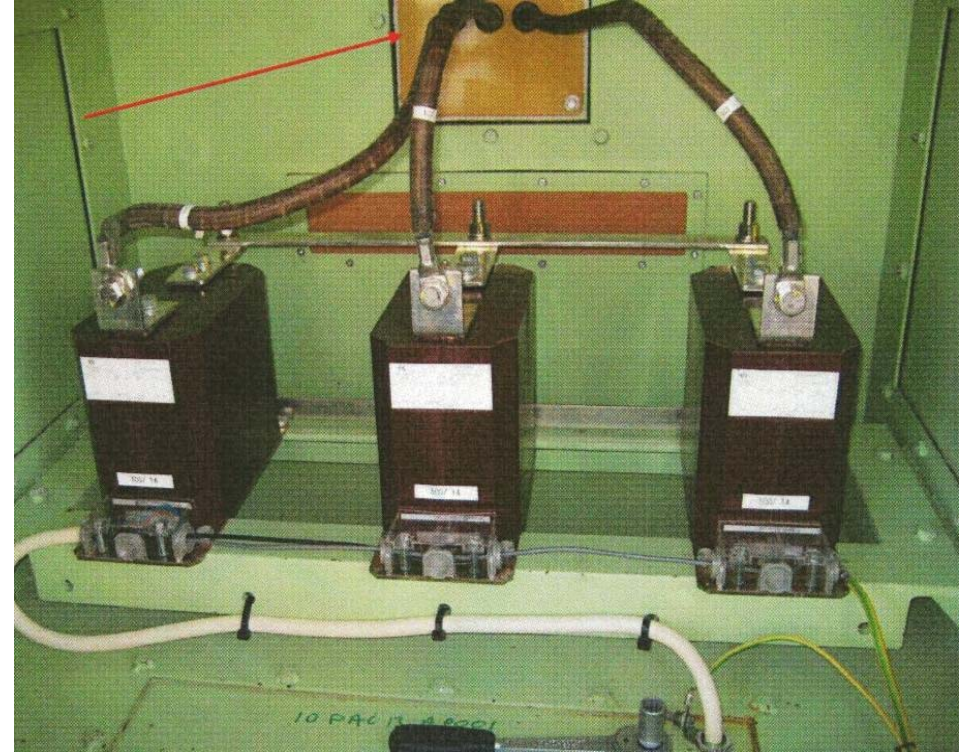
Image of winding connections. Neutral Cables and internal connections not spaced apart (arrowed)

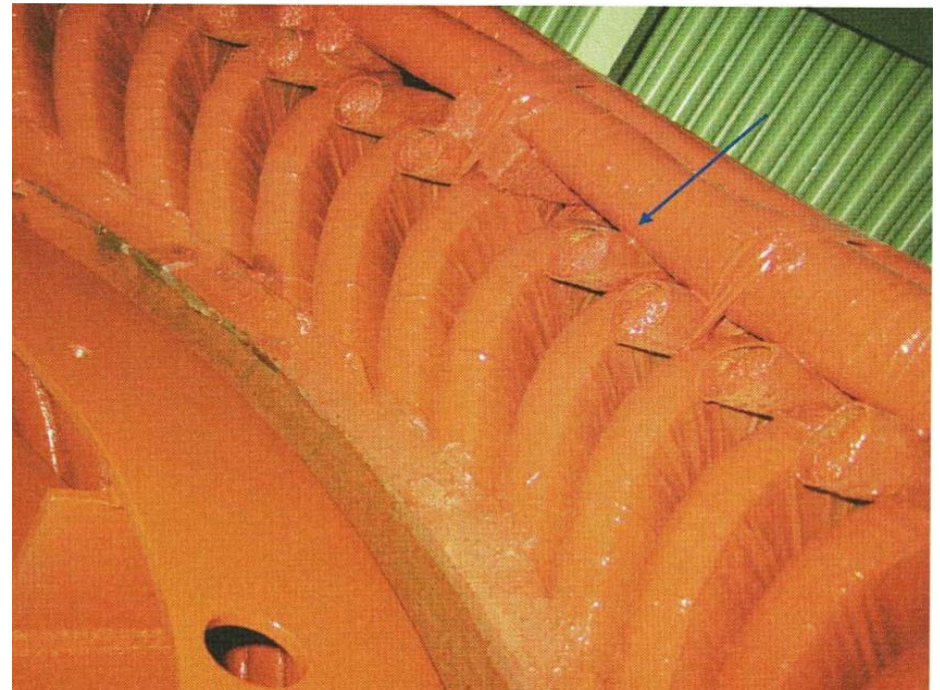
Image of coil – coil connections touching a neutral cable (arrowed) = design issue

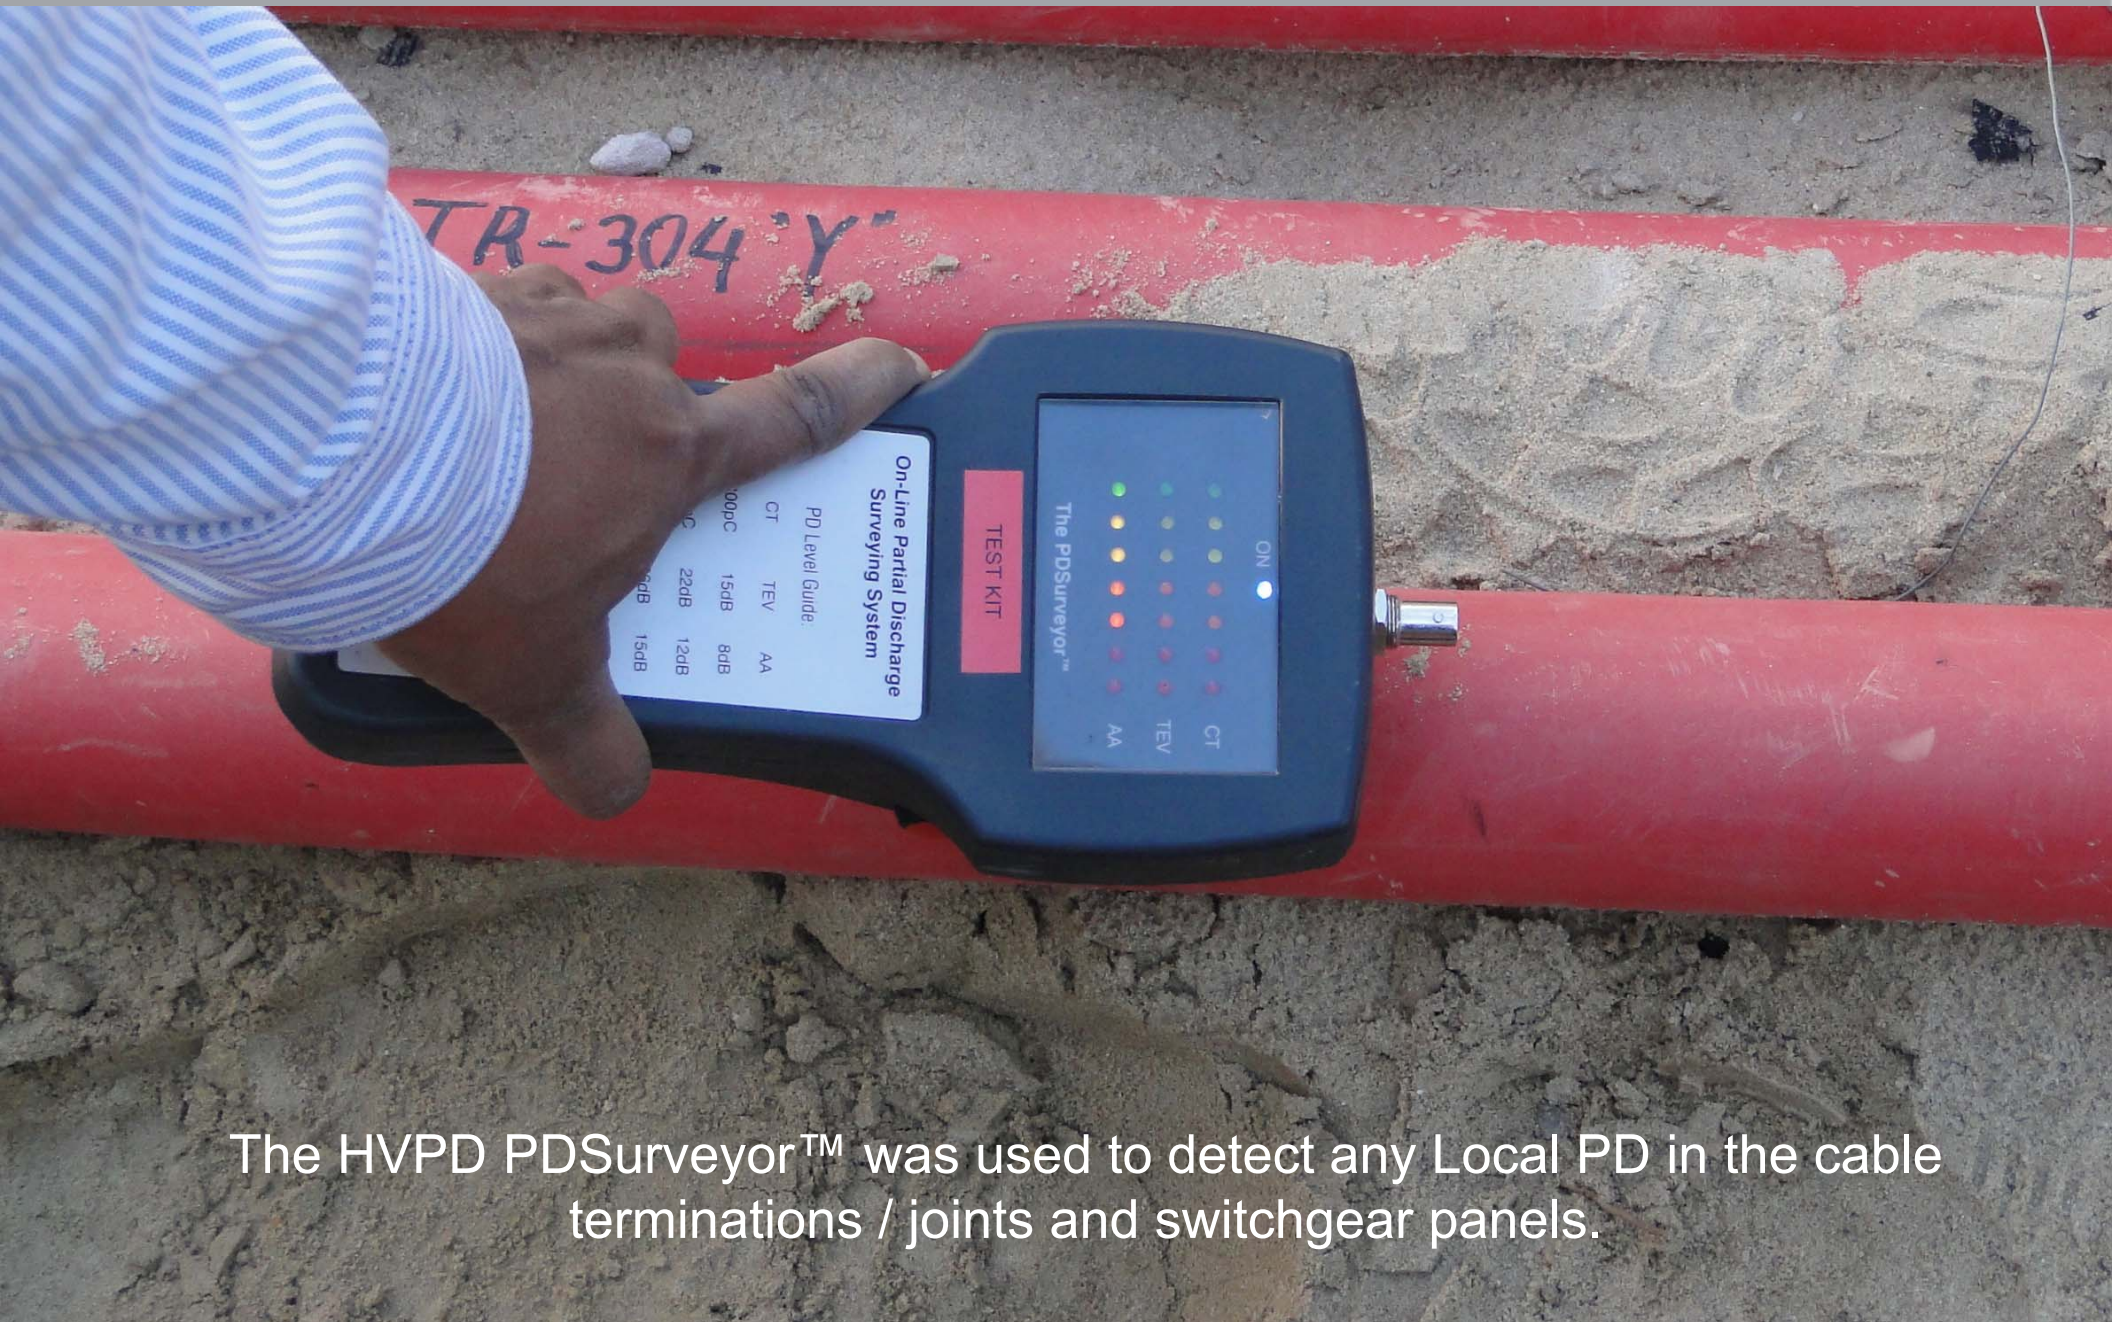
The HVPD PDSurveyor™ was used to detect any Local PD in the cable terminations / joints and switchgear panels.
