Introduction to PD

October 2014

Presented by:
Dr Lee Renforth,
Managing Director
HVPD Ltd

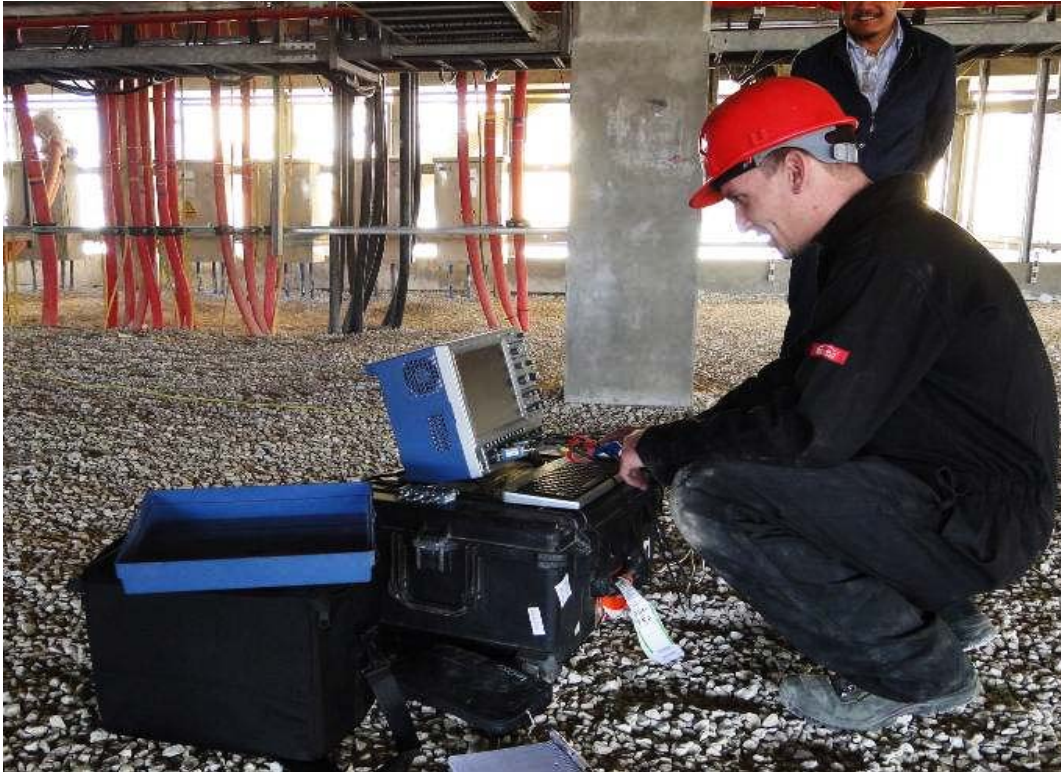
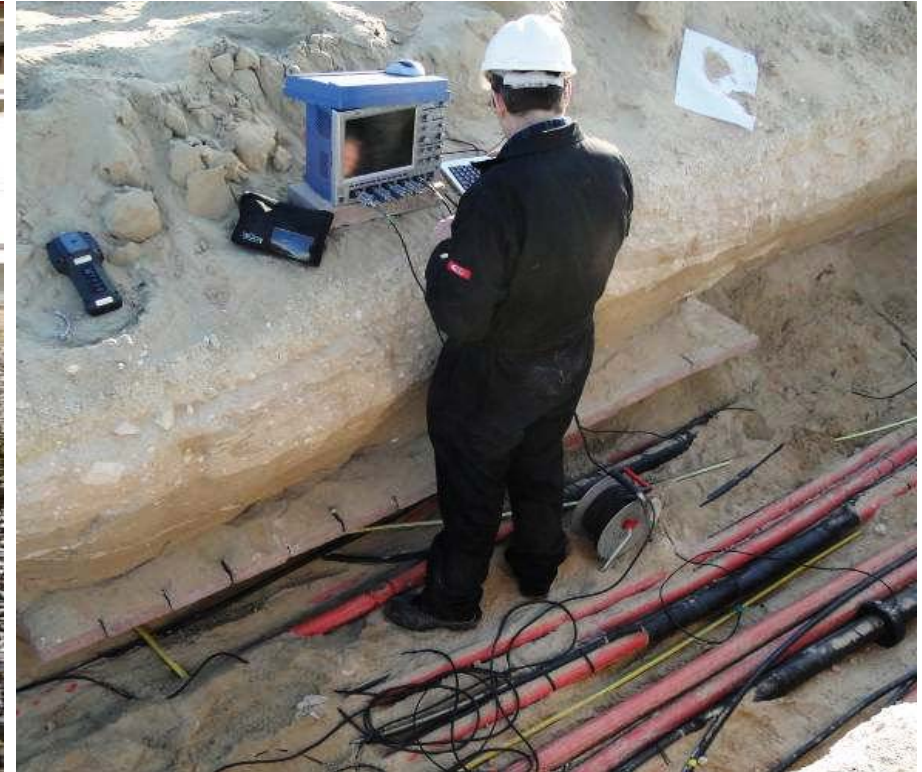
The HVPD Longshot™ unit was used to test and locate the discharging joints.

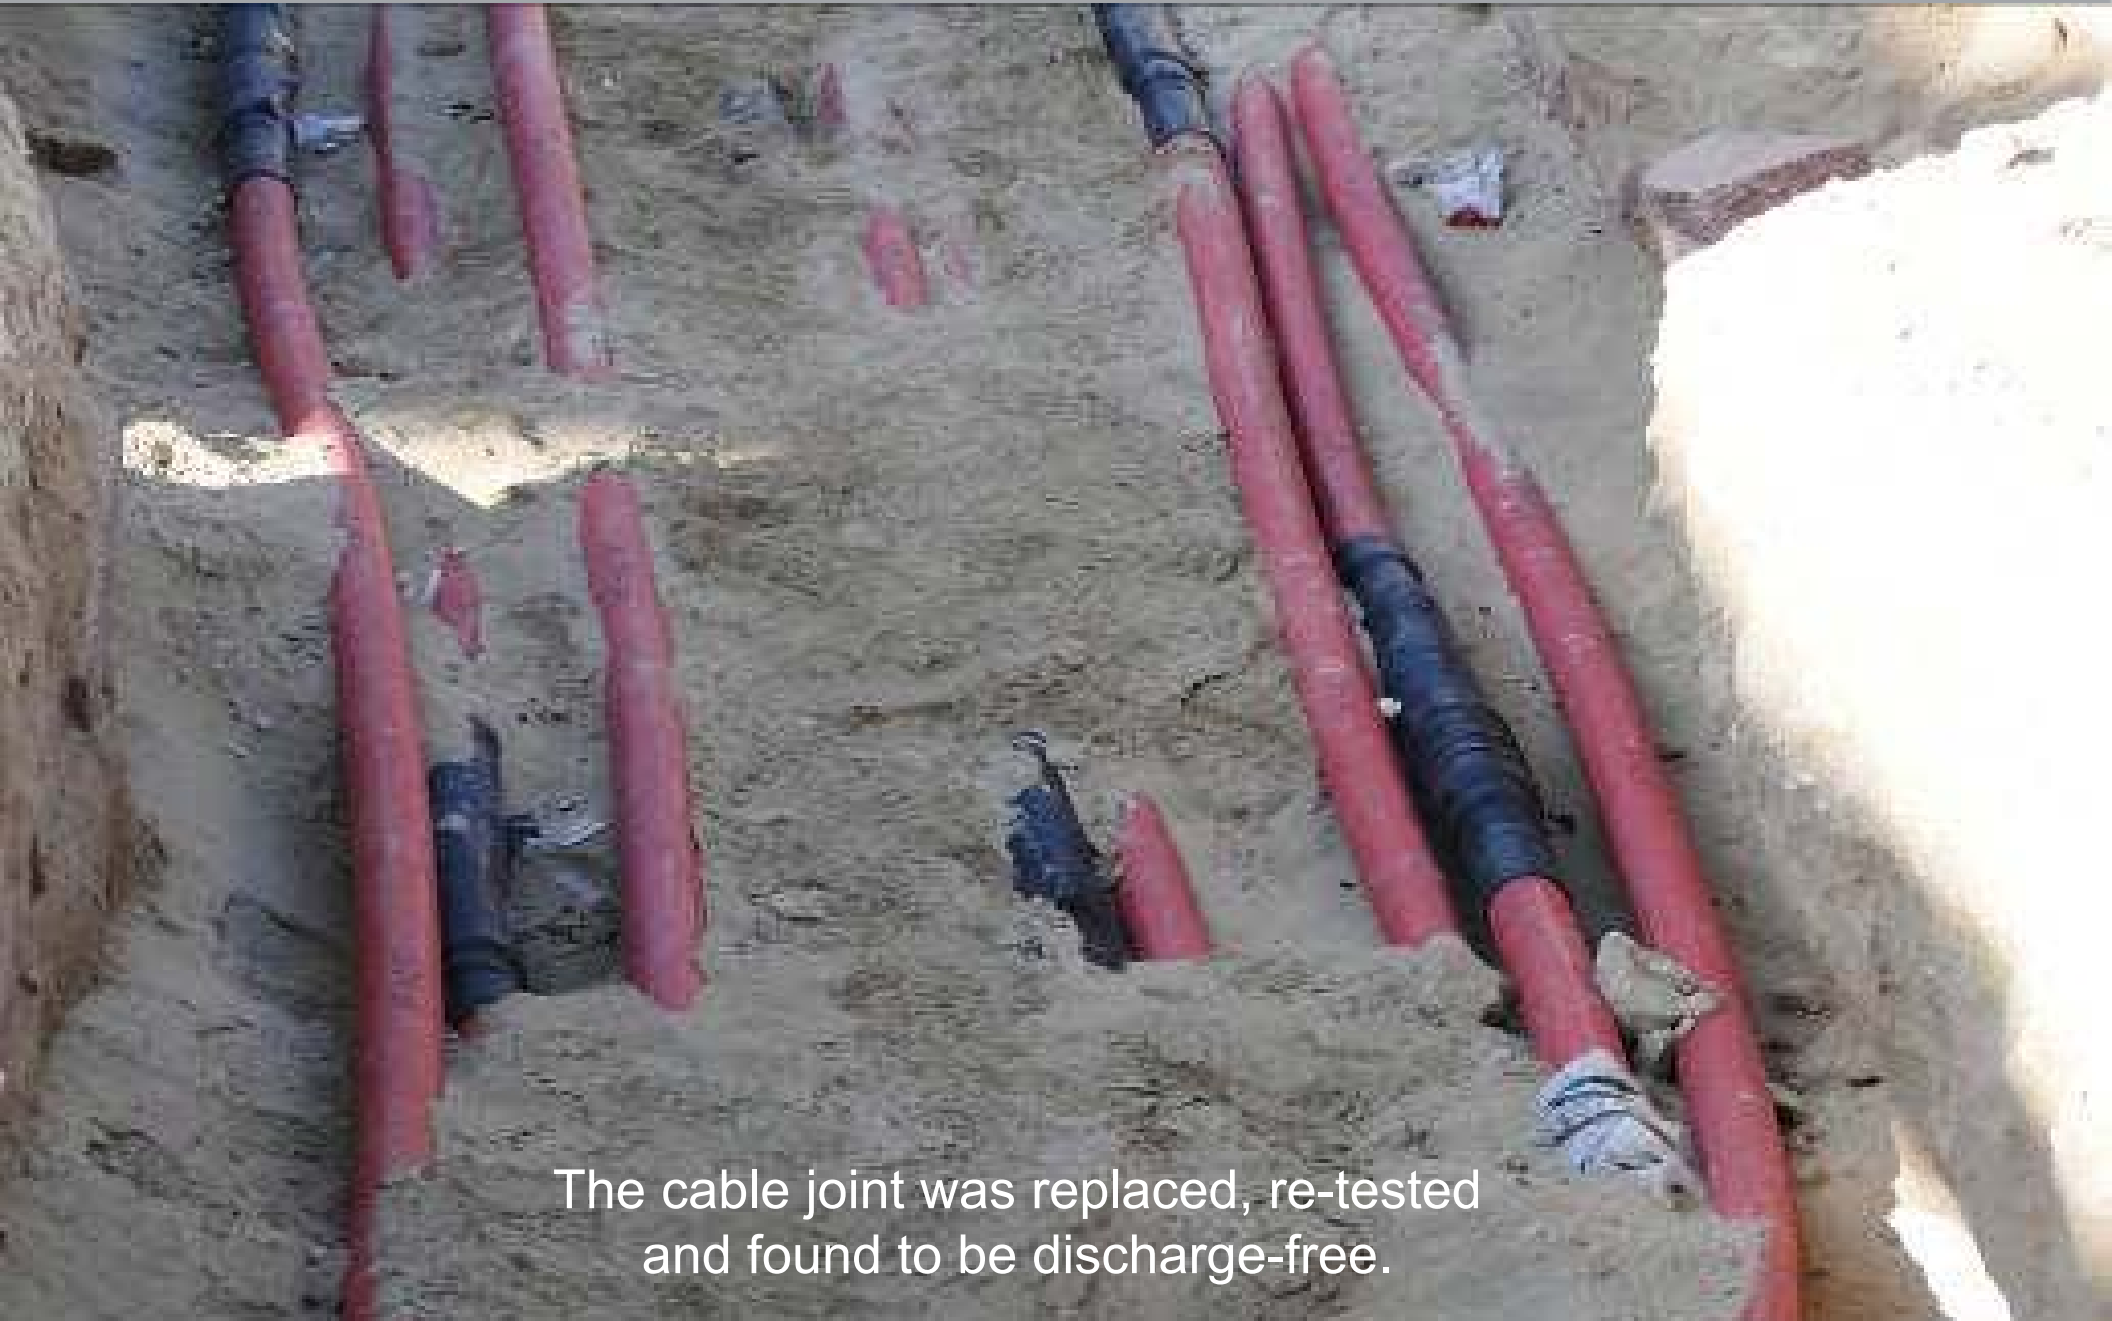
- PMap© software was used to create a map of the 1956 m cable.
- The source of PD activity was located within the Red Phase cable of seawater pump Tx302 at 1770 metres out from the 34.5 kV main substation (or 185 metres out from the Seawater Pump Transformers).
- This corresponds with the location of Joint No.3 on this cable as shown below.

The cable joint was replaced, re-tested and found to be discharge-free.

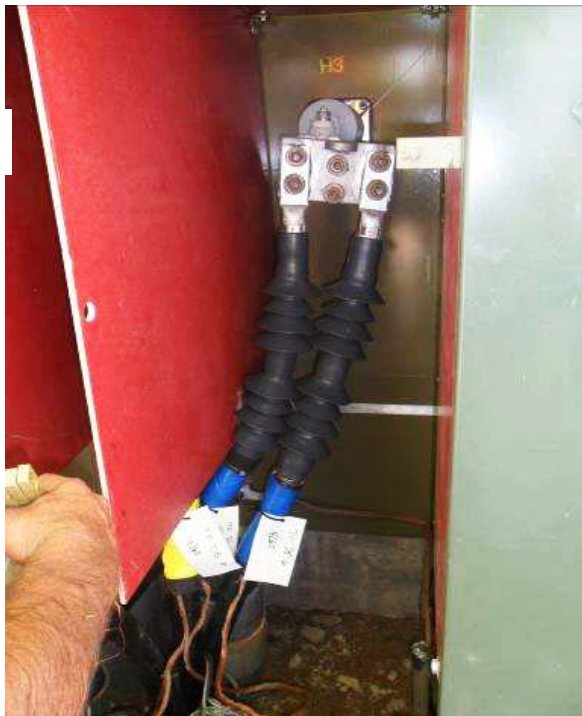
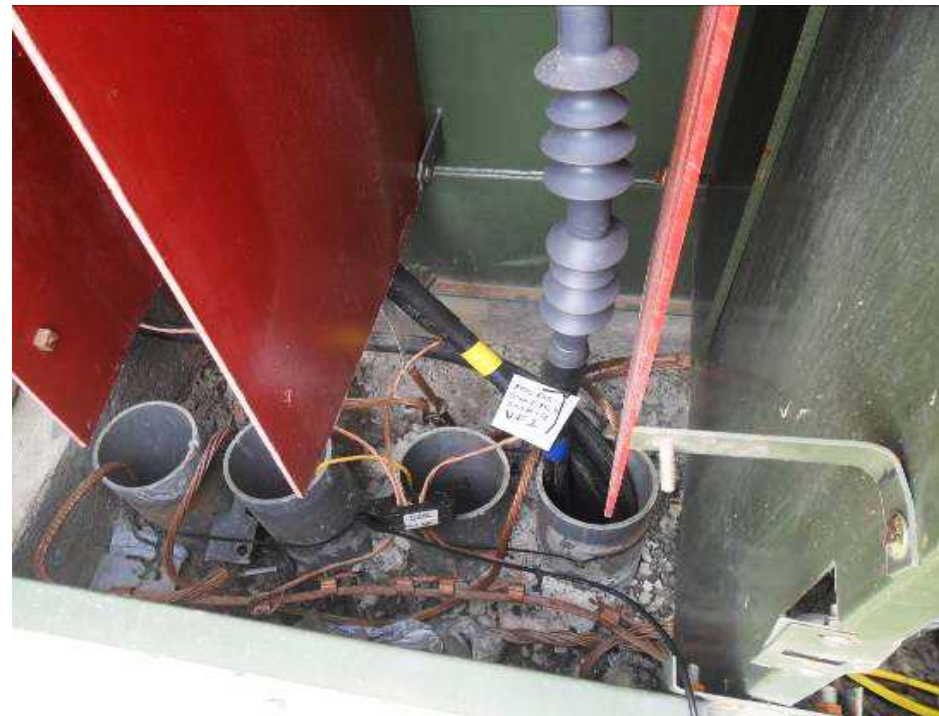
- **Poor workmanship** was the main contributing factor to the surface PD activity detected.
- **Signs of PD activity** on the cable terminations
- The rubber stress cone termination had been completely eroded.

- Re-termination of the cables into the six 'RED PD Level' padmounts.
- Further OLPD tests showed no PD activity and confirmed the rework had been effective.
- The customer was advised that regular, periodic OLPD 'screening' tests should be carried out.

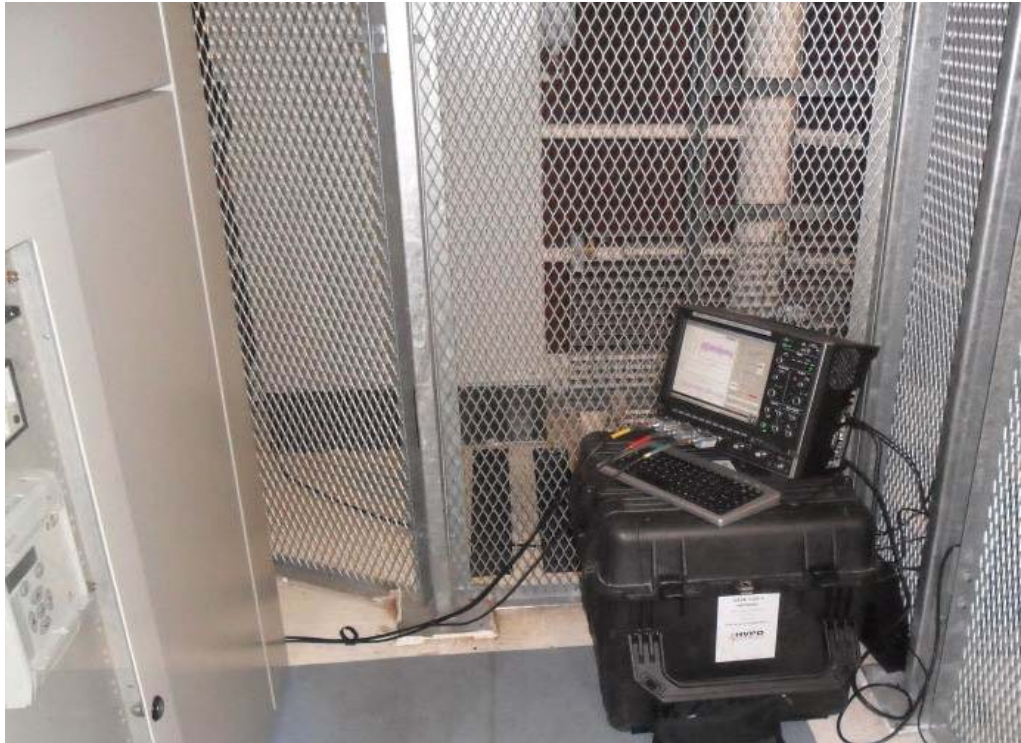
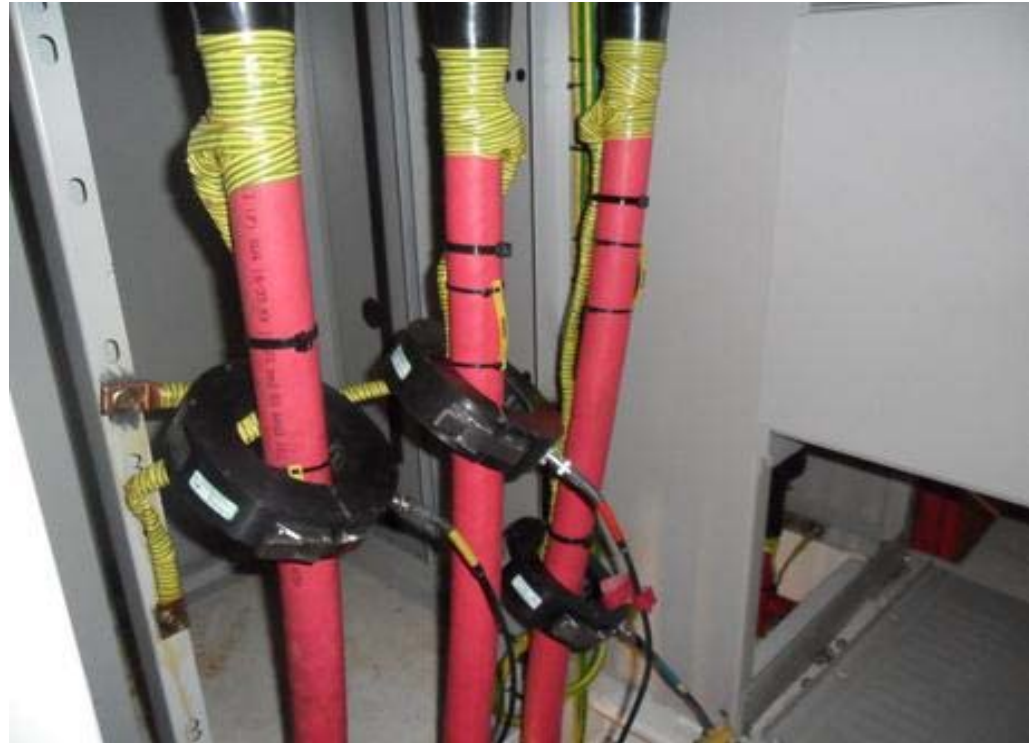
- High PD magnitudes in excess of 6,000 pC, with average levels of 1,871 pC detected on Yellow phase.
- Test identified the PD source was the Y ϕ local turbine 33 kV transformer/cable joint.
- Measurement of PD pulses on wind turbine cable feeder show clear direct & indirect reflected pulses.
- Joint location was confirmed at 52 metres from the RMU.

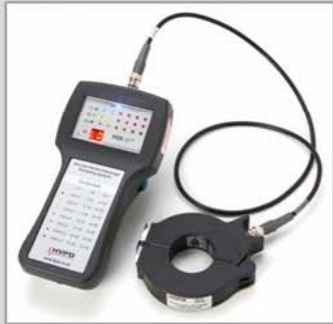
PDS Air™ with TEV, HFCT and Acoustic Sensors

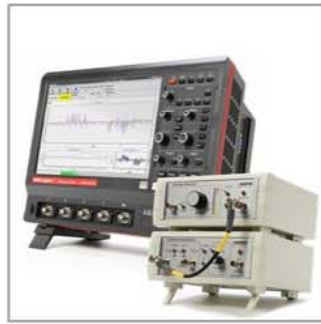
HVPD Longshot™ 4-channel Diagnostic OLPD Spot Tester

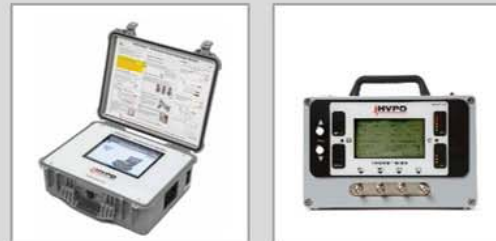
HVPD Multi™ Portable & HVPD Mini™ Portable OLPD Monitors

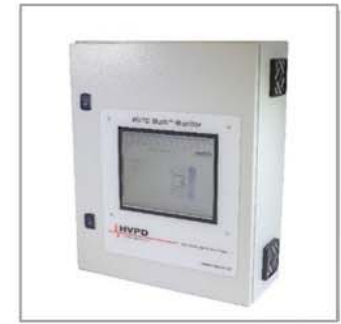
HVPD Multi™ Permanent Monitor (16 to 96 Channels)

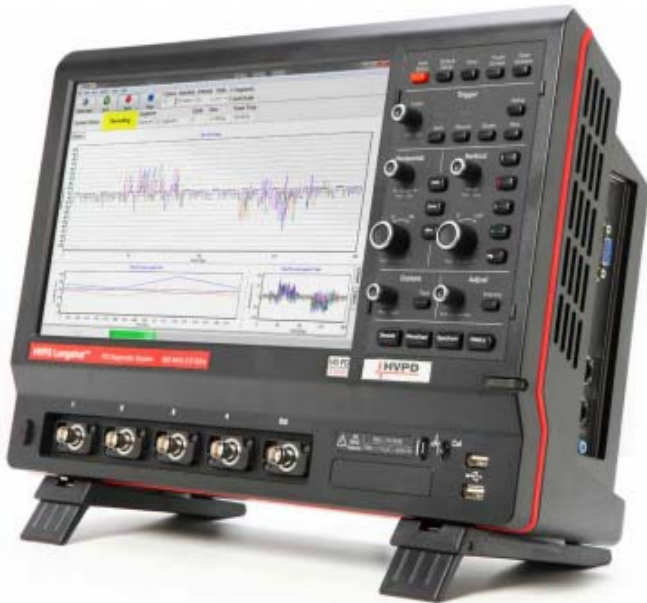
- 4-Channel, synchronous OLPD test unit
- Captures PD activity using very high speed data acquisition capability (100–500 MS/s)
- Diagnostic PDGold© v7 software with unique ‘*Event Recogniser*©’ software modules differentiates between PD activity and any electrical noise and RF interference.
- An automatic, detailed analysis of pulse frequency, waveshape and other signal waveform characteristics.

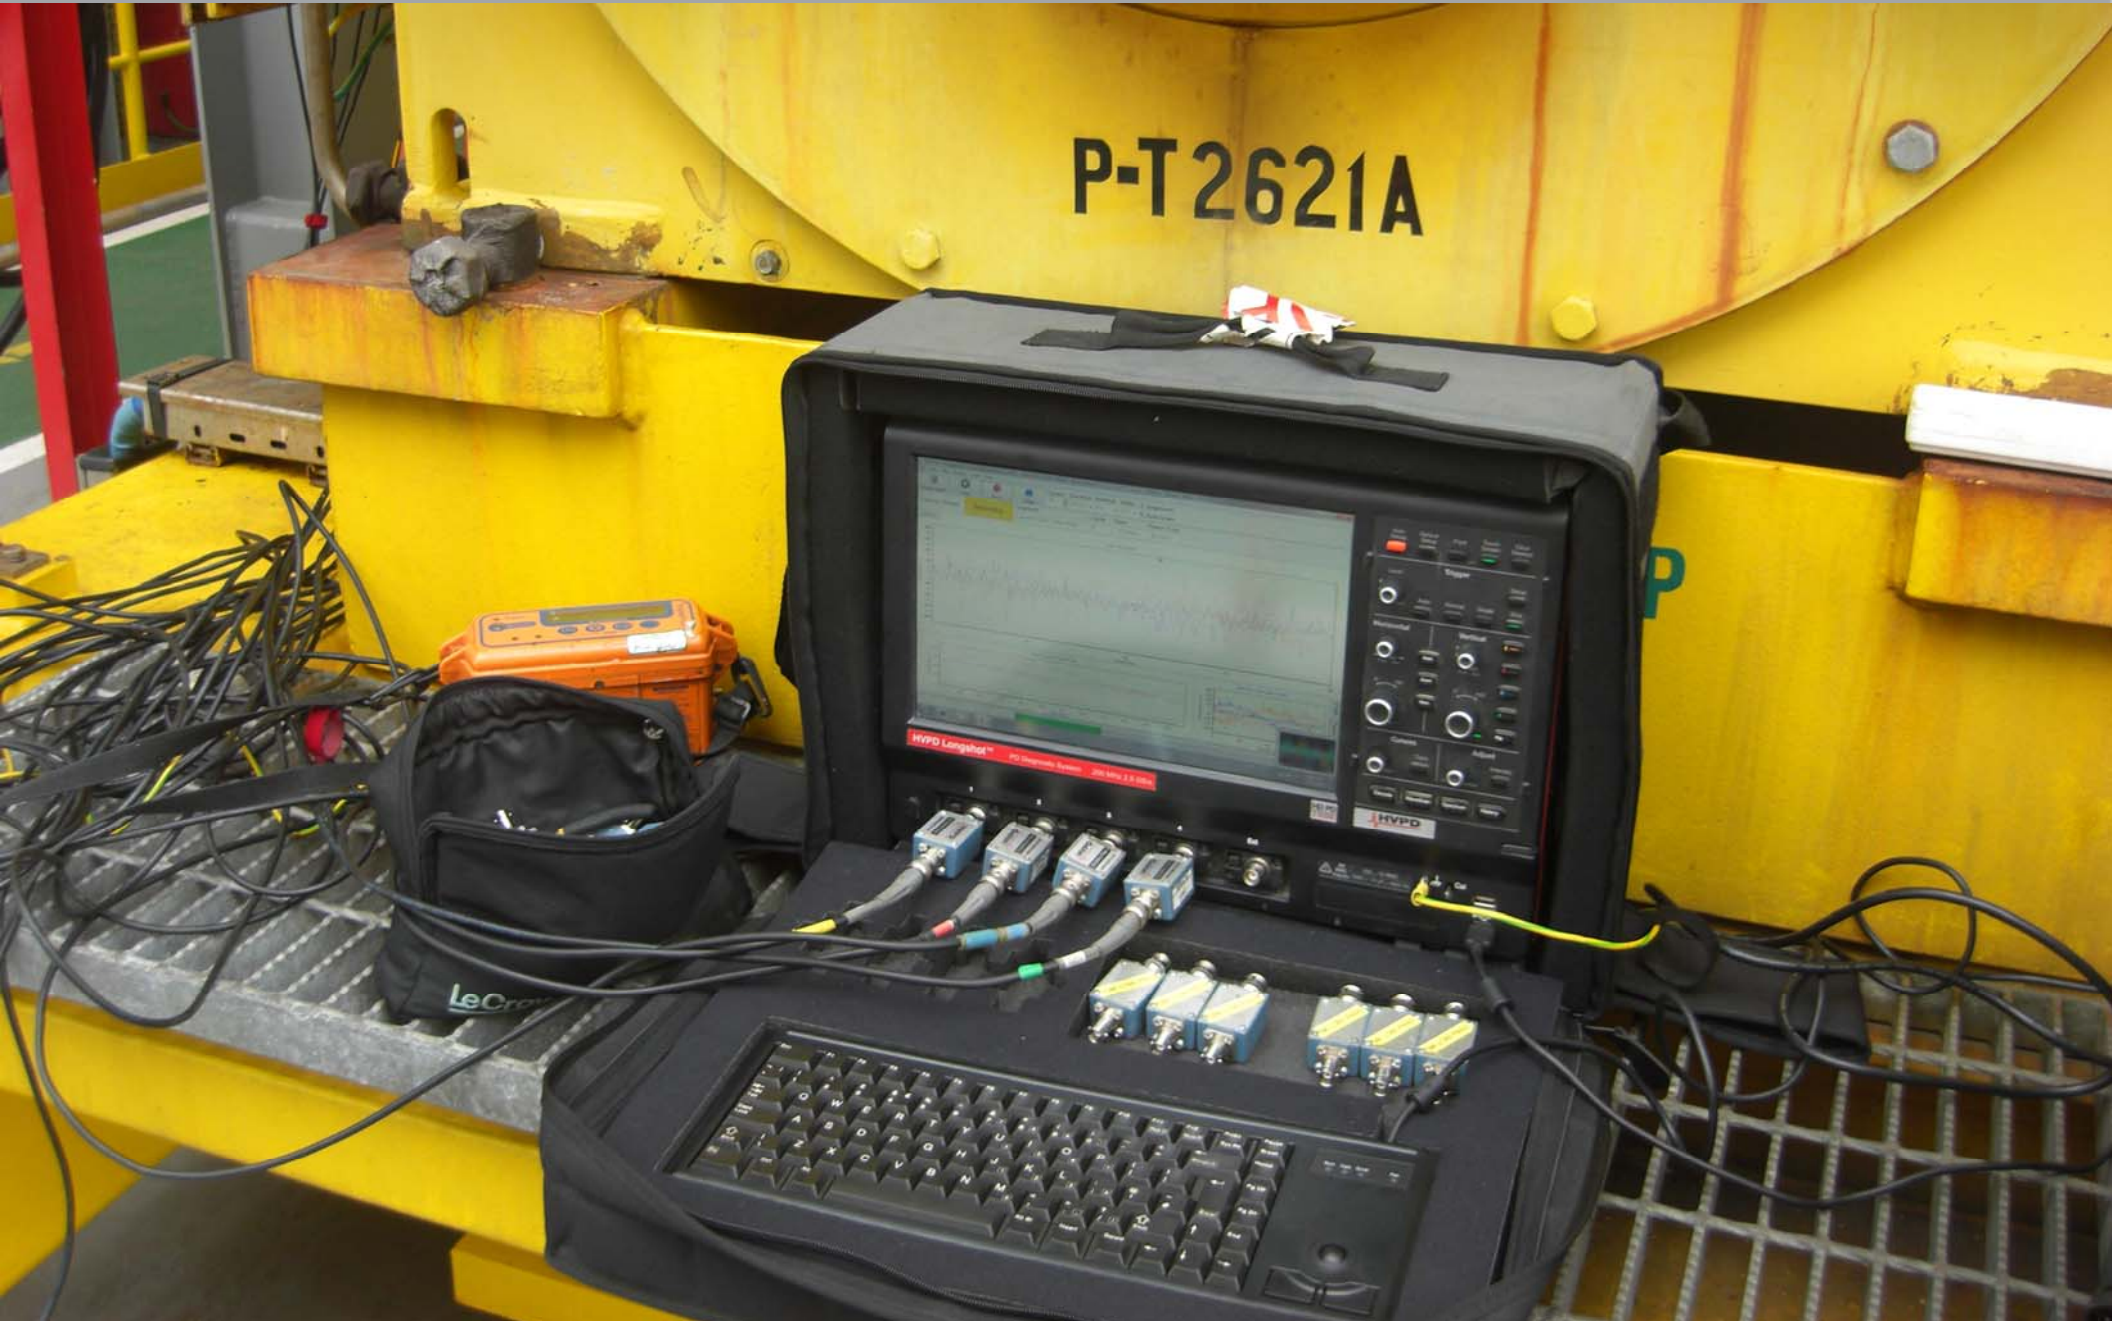
- Impulsive events **extracted and categorised by software** as cable PD, local PD and noise.
- Even amongst noise interference, **PD data can still be extracted.**

One power cycle of raw data from HFCT sensor

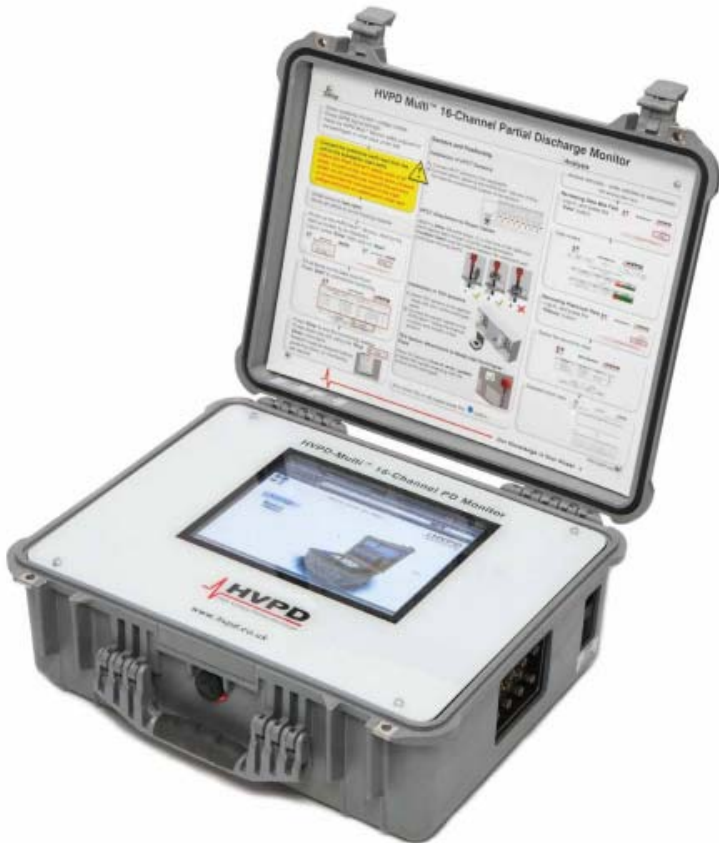
- 24/7 diagnostic portable OLPD monitoring technology for MV and HV Plant
- Measures, analyses and logs Cable PD, Local PD and Noise
- 'Knowledge-Rule' based PD criticality measurement (0–100)
- Remote access connection via LAN/Modem
- 16-Channel (HFCT/TEV/HVCC) with optional add-on 32x channel AA sensor modules

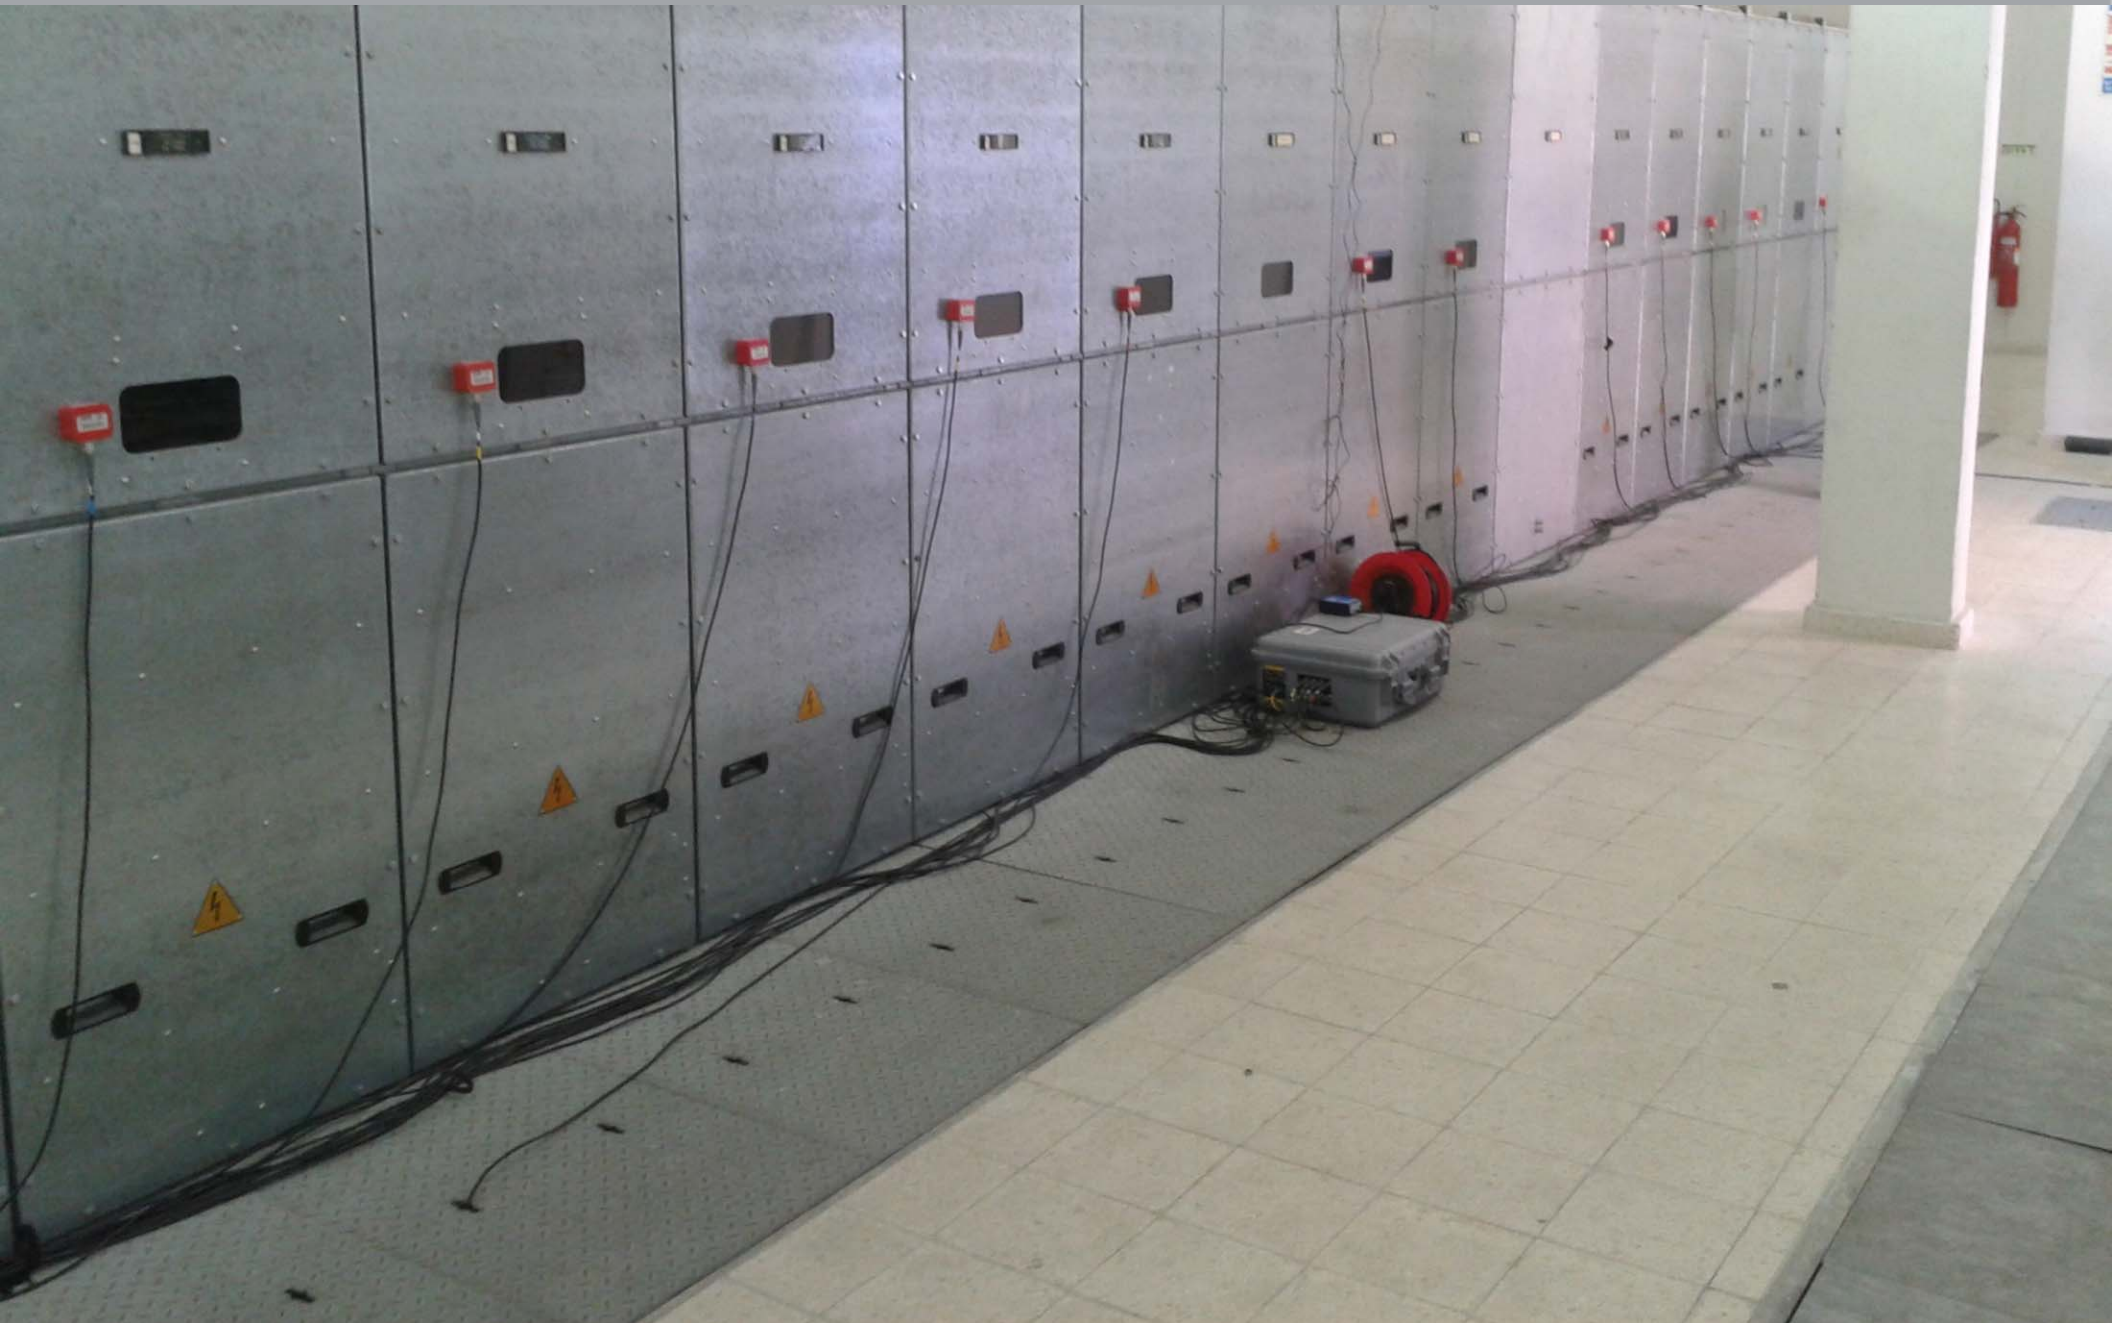
- Criticality league table
- Highlights most critical circuits
- Updated every 24 hours
- Link to data graphs
- Criticality algorithm, specific to plant

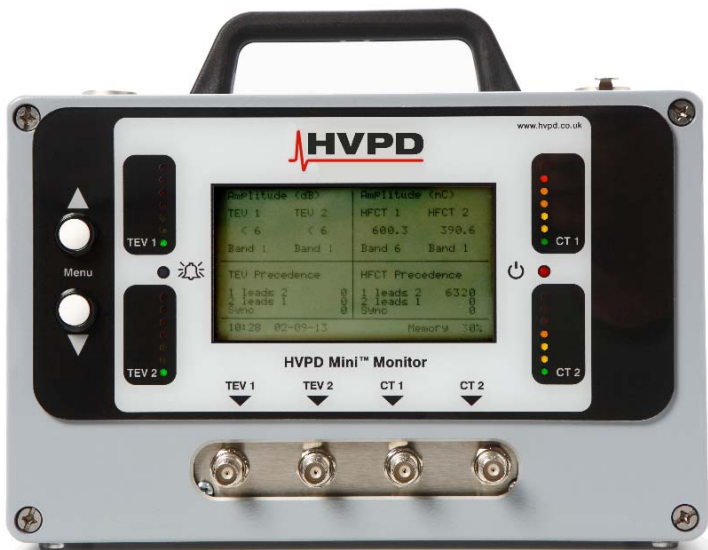
- Low-cost 24/7 PD monitoring technology for MV cables, switchgear & other plant
- Incorporates up to 4x portable PD sensors
- Measures and logs both cable PD and local PD (PD magnitude & 'count' – no. of pulses)
- Stores up to 12 months of data on local flash memory
- Uploads PD data to server every 24 hours via GSM/GPRS Modem
- Compact, lightweight and easy to set up unit for portable installations

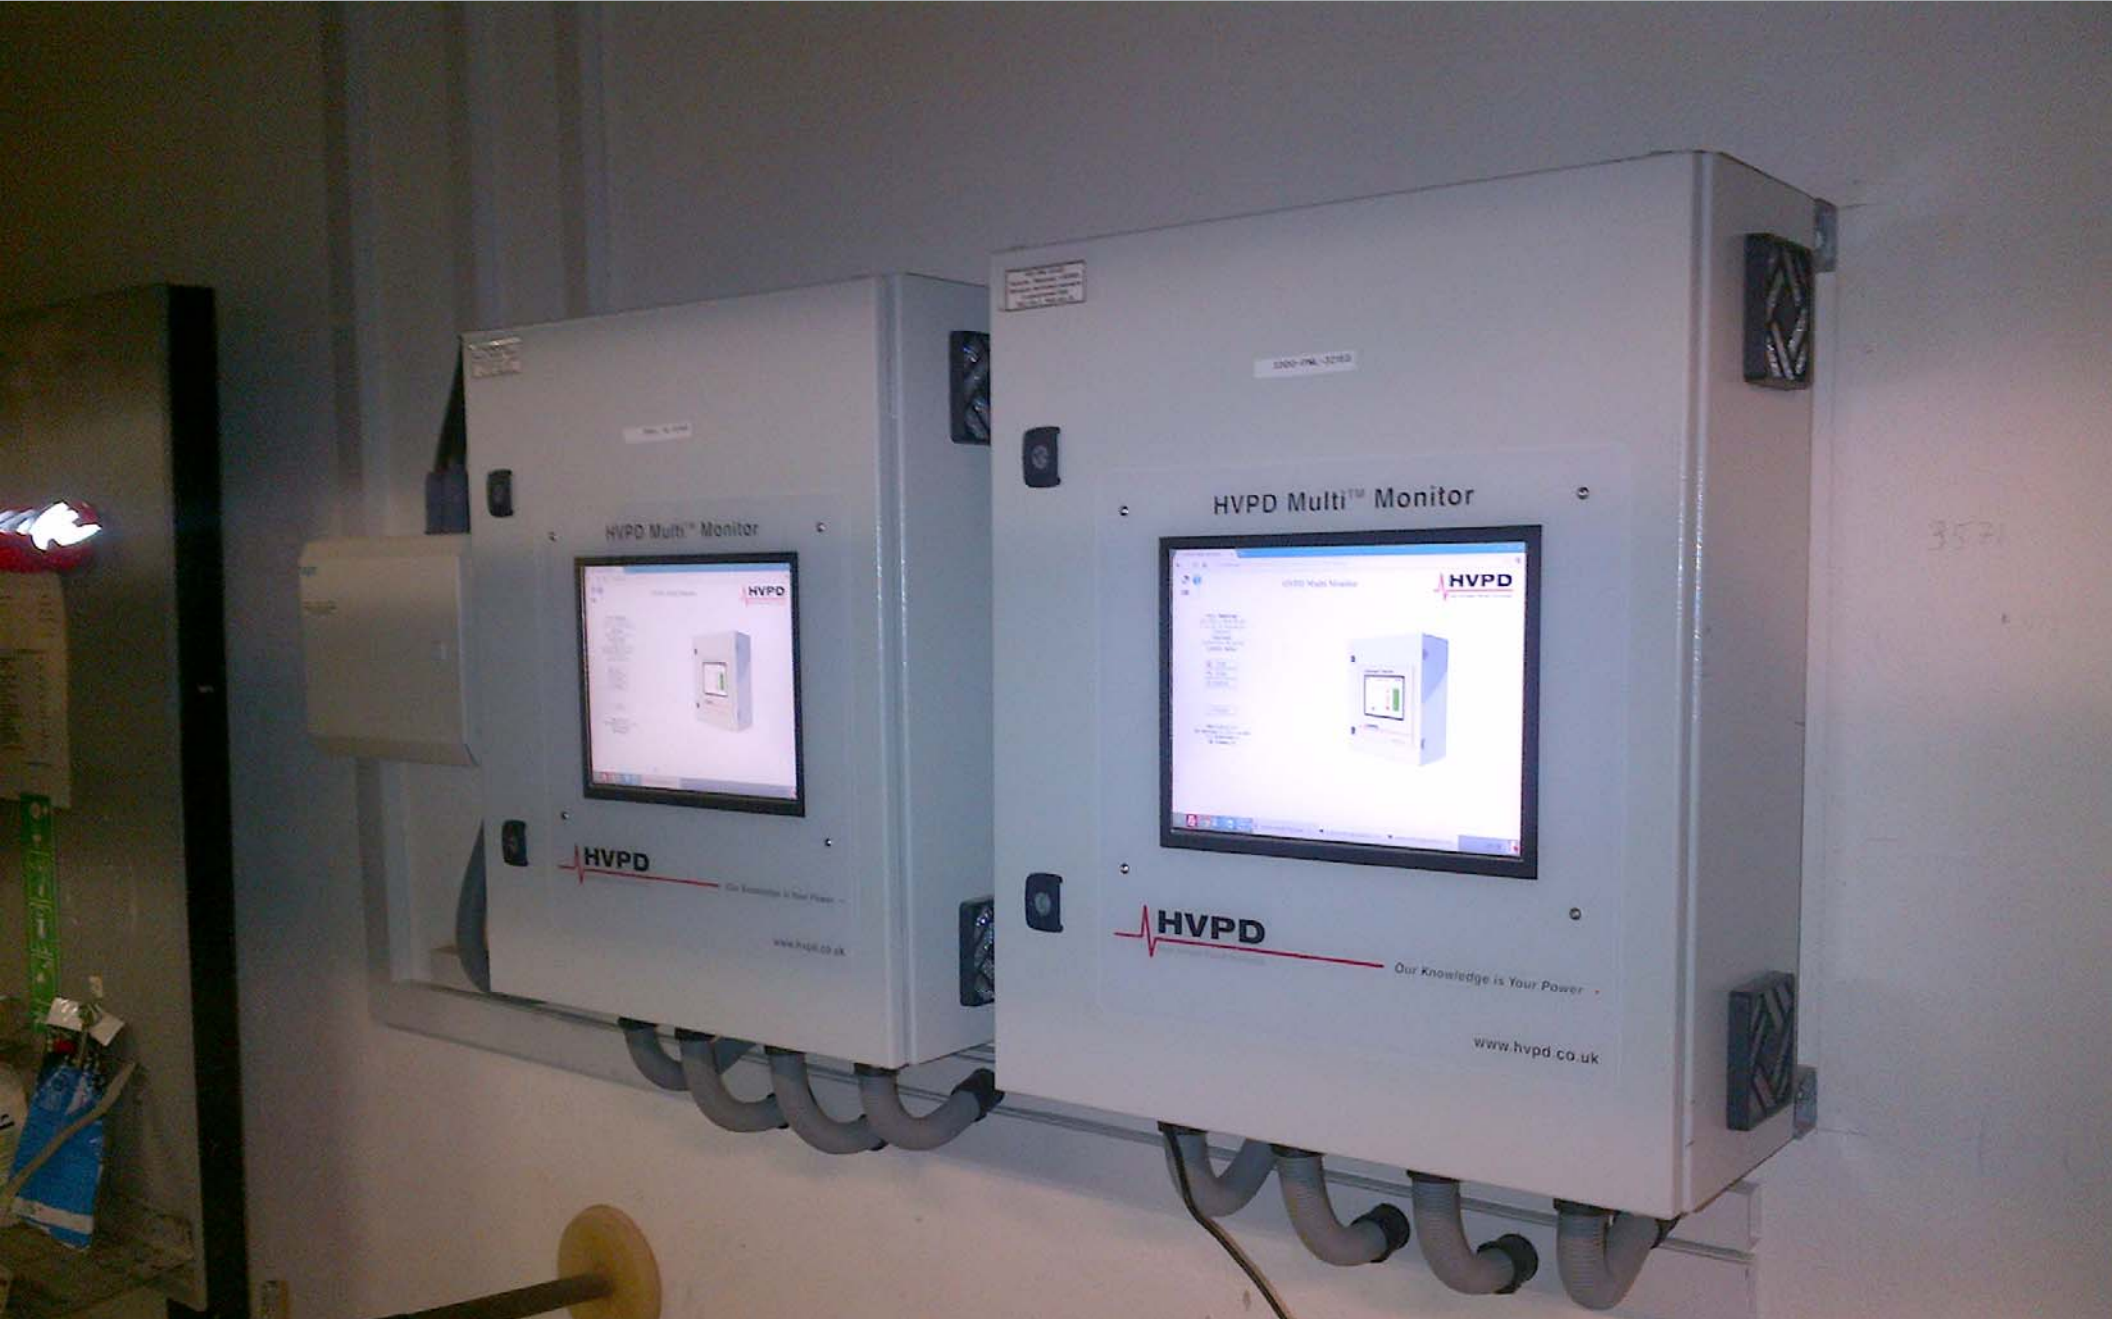
- 24/7 monitoring of PD in switchgear, cables and rotating HV machines
- Non-intrusive, inductive sensors
- Remotely accessible with GPRS/3G modem
- Onboard automatic analysis software provides differentiation of all PD pulses from noise
- Can monitor up to 4x rotating HV machines

- The HVPD-Multi™ Monitor does not provide automated alarms but provide '*flags*' for further engineer investigation
- These '*flags*' can signal an increase in either PD level or PD activity but can also be caused as a result of network switching
- Each '*flag*' is investigated by HVPD engineers before a diagnostic decision is made regarding preventative maintenance interventions.

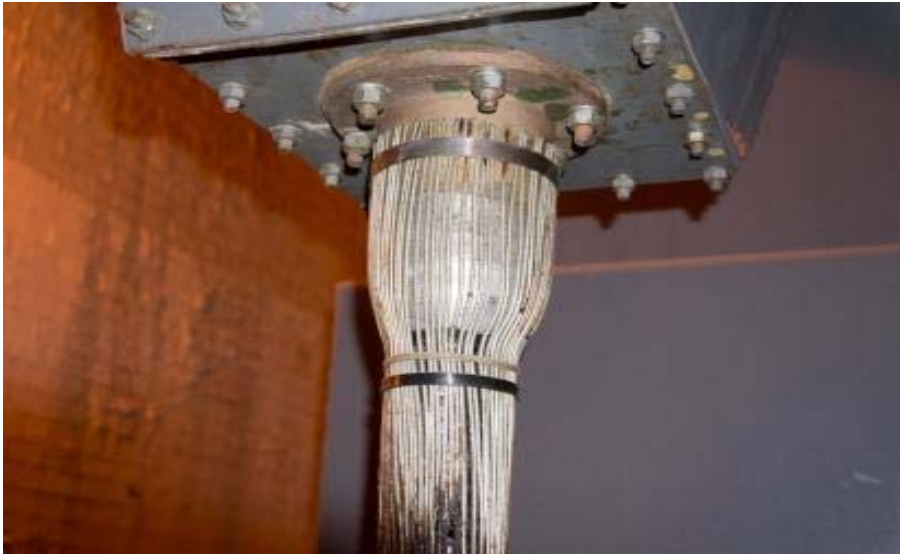
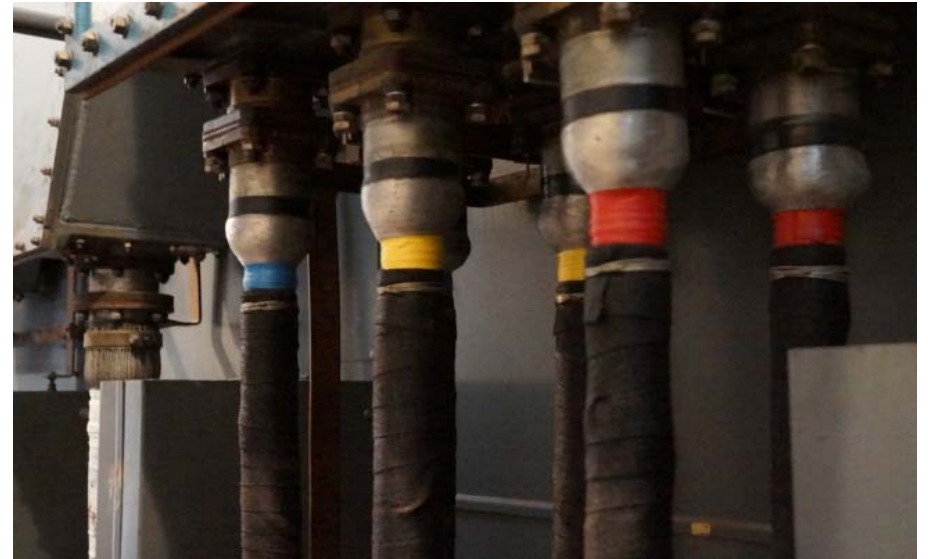
Summary Data of 33 kV Worst Performing Circuits in Networks A & B (2002-2008)

No. of Circuits	Total Length (est.)	Average Circuit Length (est.)	Average faults per annum (Av. 7 years 2002 to 2008)	Faults per 100 km p.a.
Network B- 51	357 km	7.000 km	42.1	11.80
Network A - 62	434 km	7.000 km	48.6	11.19
Total - 113	791 km	7.000 km	90.7	11.47

- The suitability of cable terminations for the attachment of the HFCT sensors is the main restriction on the widespread application of the OLPD technology.
- Only around 40% of the terminations on the customer's networks can be considered as 'suitable'.
- For future testing, it has been suggested that the customer modify solidly bonded terminations.

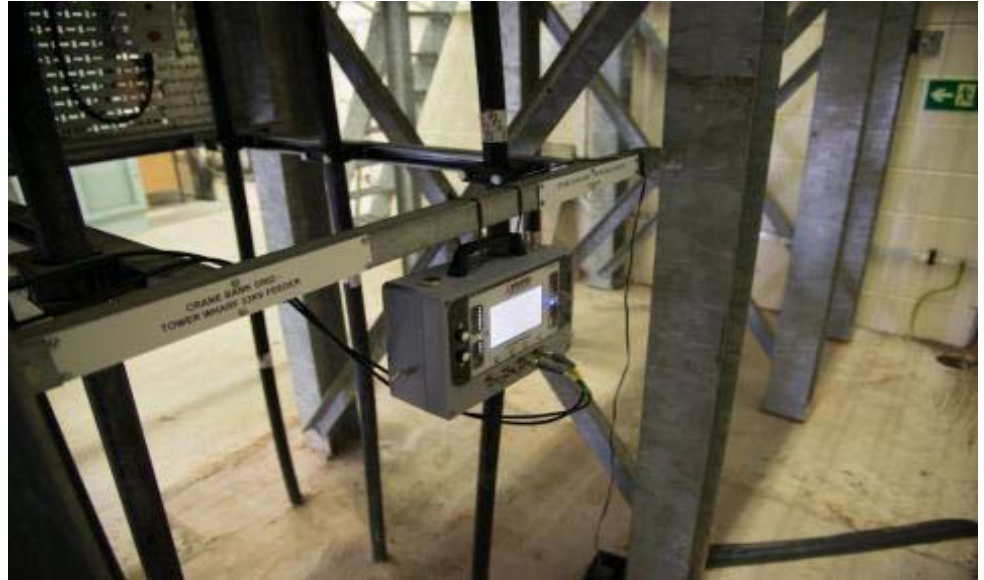
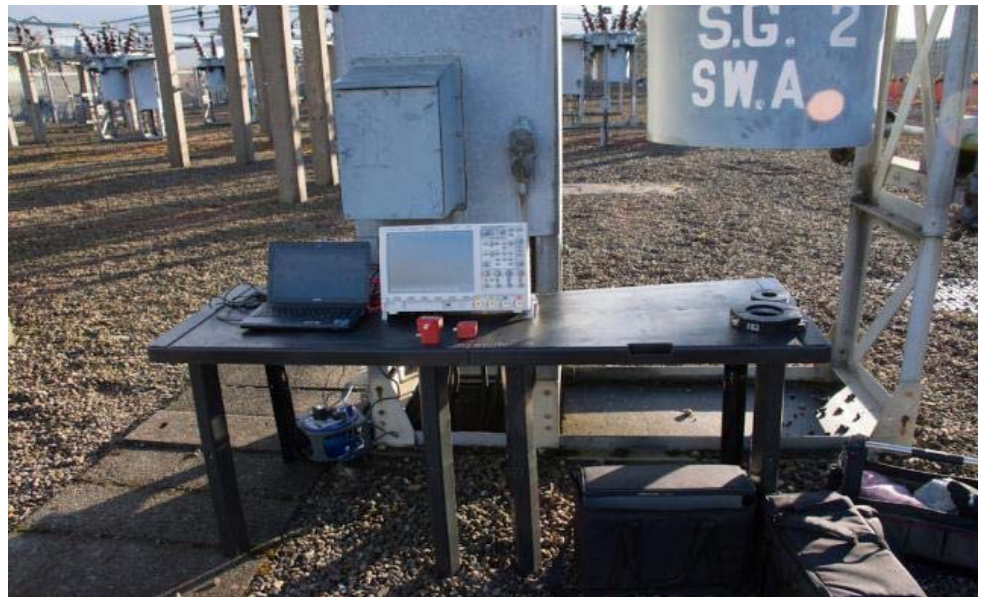
10% of all of 39x 33kV cable circuits tested are the **Red Condition Category**.

No. of Circuits	Condition	%
26	Discharge within acceptable limits	66
7	Some concern, monitoring recommended	18
2	Some concern, regular monitoring recommended	5
4	Major concern, locate PD and then repair or replace	10

4% of all 25x 11kV circuits tested in this project are in the **Red Condition Category**.

No. of Circuits	Condition	%
18	Discharge within acceptable limits	72
4	Some concern, monitoring recommended	16
2	Some concern, regular monitoring recommended	8
1	Major concern, locate PD and then repair or replace	4

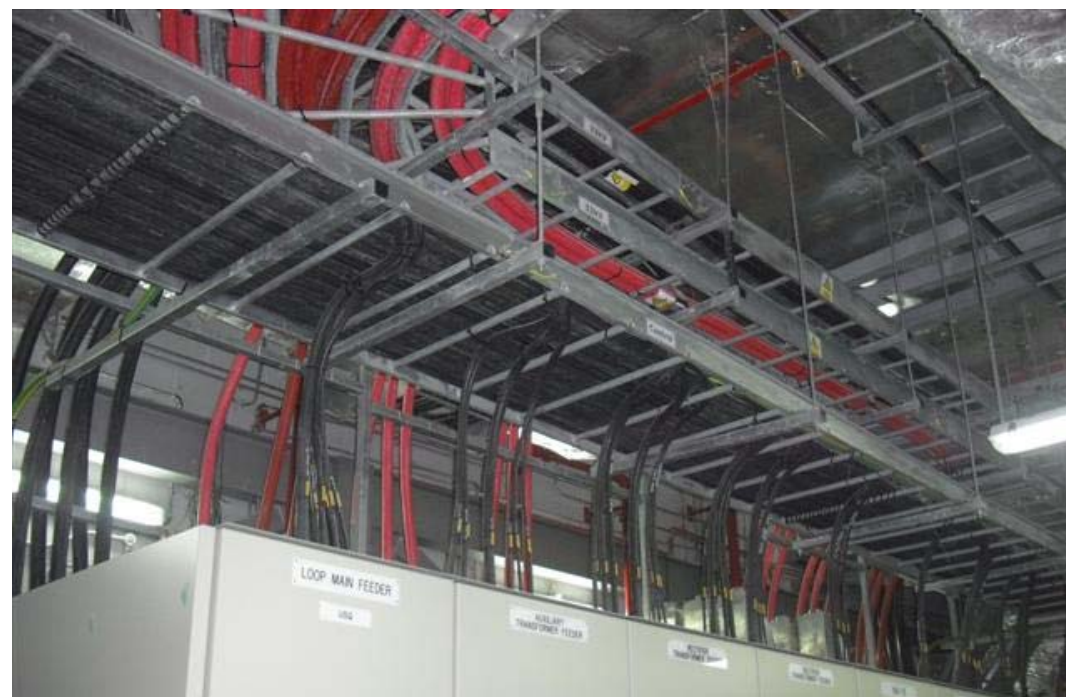
- OLPD testing was carried out in response to a number recent faults* of 33 kV cable joints within the customer's network.
- The faults led to disruption of the power supply to the Metropolitan rail system.
- The purpose of the testing was to measure and locate any PD activity within the cables with particular focus on the cable joints.

** It should be noted that this was a newly installed cable system that had been in-service for just over 12 months before the faults started to occur.*

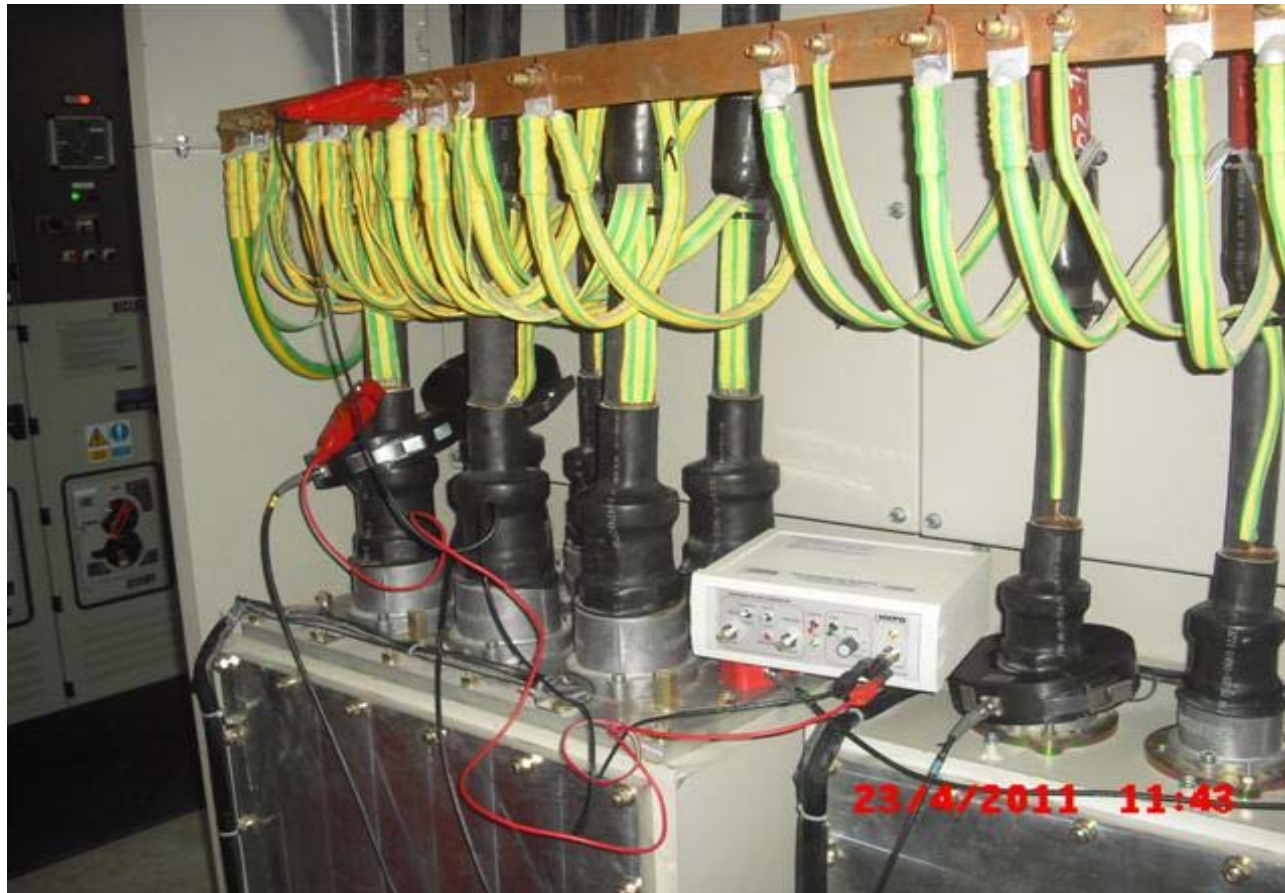
- On-line Cable PD Mapping using the HVPD Longshot™ test unit and Portable transponder.
- Tests started with calibration testing with pulse injection HFCTs.

- Cable PD signals have been detected on Blue Phase with cross-talk (lower magnitude) on Red and Yellow phases.
- The source of PD was located to Joint Number 2 (Jt2) using the on-line PD mapping technique.
- The faulty joint on this cable was replaced and re-tested using the HVPD Longshot™ test unit to verify the repair was good
